Fire Risk Assessment Review

Poynter House

Edward Woods Estate
Queensdale Crescent
London, W11 4TA

Date of Review: 12-05-2023

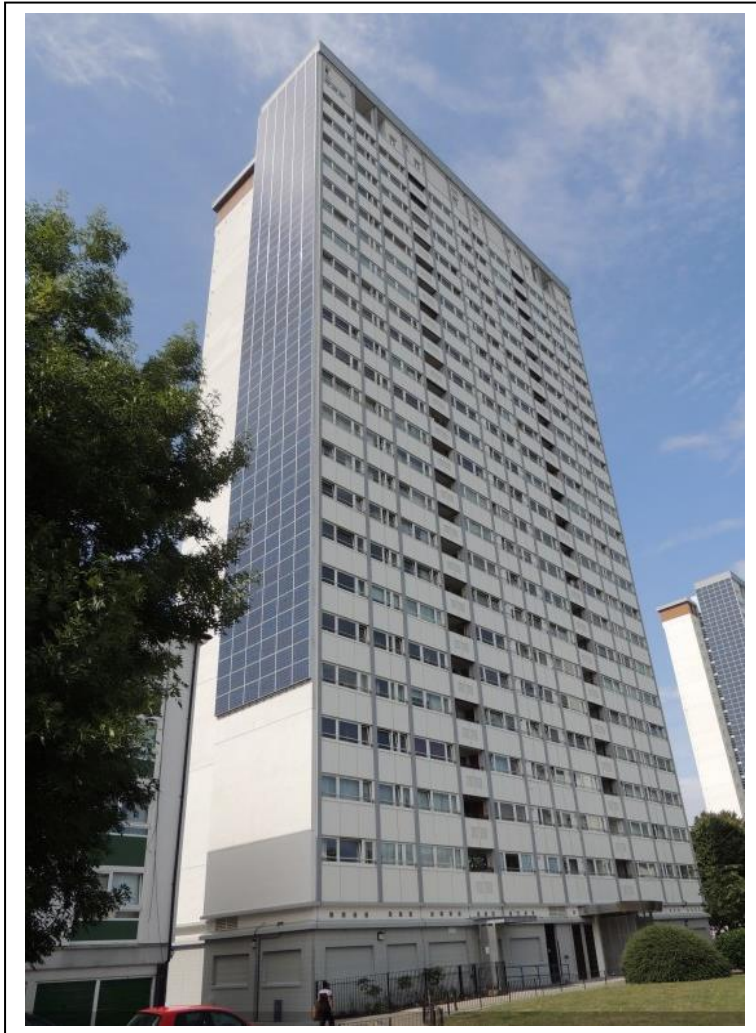
The towers of the Edward Woods Estate (Norland, Poynter, Stebbing House) are risk assessed annually by LBHFs competent contractors, CS Todd & Associates. The current FRA is valid until the 12 May 2022. The buildings are currently undergoing major capital works to renovate the RockShield and RockPanel EWI systems, upgrade the UPVC windows, remove the PV Cells (as shown in image opposite) and improve ventilation in common areas.
