Fire Risk Assessment Review

Norland House

Edward Woods Estate
Queensdale Crescent
London, W11 4TA

Date of Review: 12-05-2023

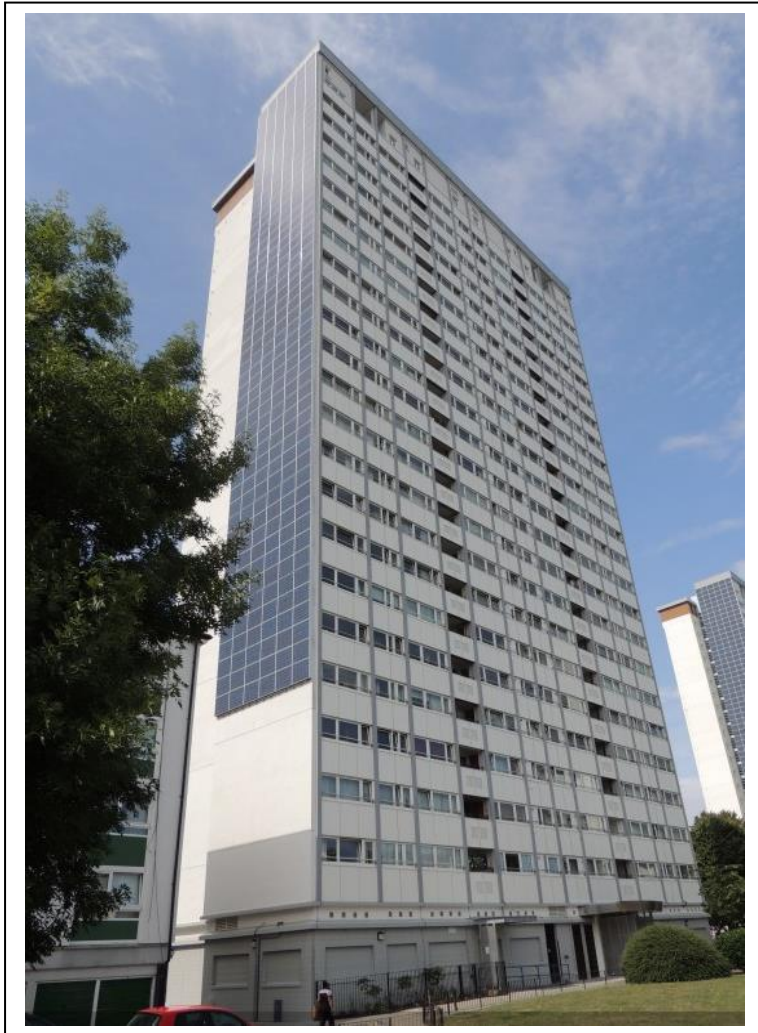
The towers of the Edward Woods Estate (Norland, Poynter, Stebbing House) are risk assessed annually by LBHFs competent contractors, CS Todd & Associates. The current FRA is valid until the 12 May 2022. The buildings are currently undergoing major capital works to renovate the RockShield and RockPanel EWI systems, upgrade the UPVC windows, remove the PV Cells (as shown in image opposite) and improve ventilation in common areas.
