London Borough of Hammersmith &
Fulham

Hartopp Point & Lannoy Point
Structural Assessment

Issue 1 | 12 February 2019

Job number 259559-00

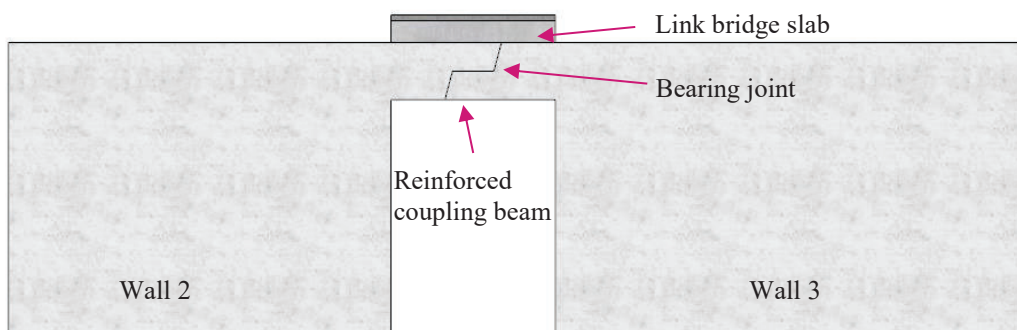
Figure 5 - The lift and stair core walls are connected via a coupling beam with a bearing joint at the centre.

Wall types 2 and 3 are connected at the centre of the link bridge via a reinforced concrete coupling beam. The coupling beam extends from the wall panels on either side to form a bearing joint at the centre (see Figure 5).

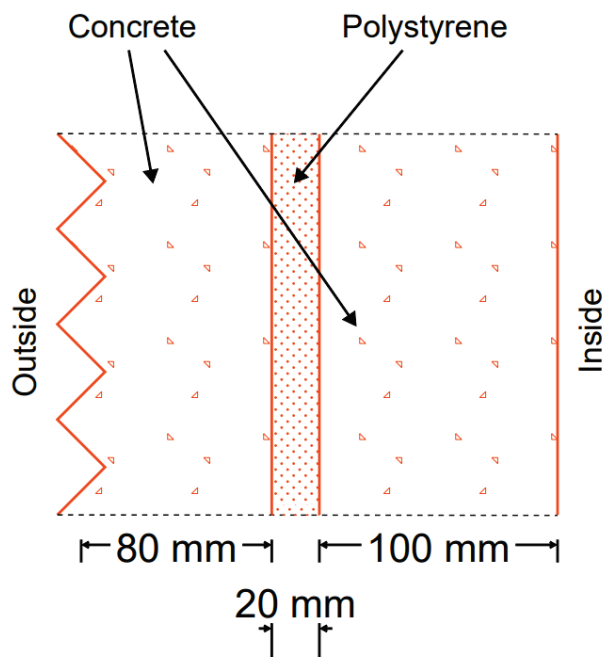
Figure 6 - Sandwich construction of external wall panels, including approximate dimensions.

The buildings' external wall and flank wall panels are made out of a sandwich construction as shown in Figure 6. The outer layer of non-structural concrete is separated from the inner layer of structural concrete by a thin layer of polystyrene insulation. It is suspected that there are ties holding the two layers together, likely stainless steel.

It was not possible to locate the ties connecting the leaves of the external wall panels and so it was not possible to inspect their condition. Refer Section 7.3 for more information.

It is also recommended that wall ties are provided to tie the inner and outer leaves of the external wall panels together. This applies to all of the flank walls and external wall panels on all two tower blocks. While it is believed that stainless steel or galvanized steel wall ties do currently exist [14], inspection to determine the number, location and condition of ties is extremely difficult. Additionally, in their 1985 report on TWA buildings [1], the BRE recommend that additional ties should be provided on the basis that they may have suffered from fatigue, due to the stresses induced by wind and thermal effects and the fact that no amount of sampling can eliminate this risk. The fixing of the external wall panels back to the building should also be improved.

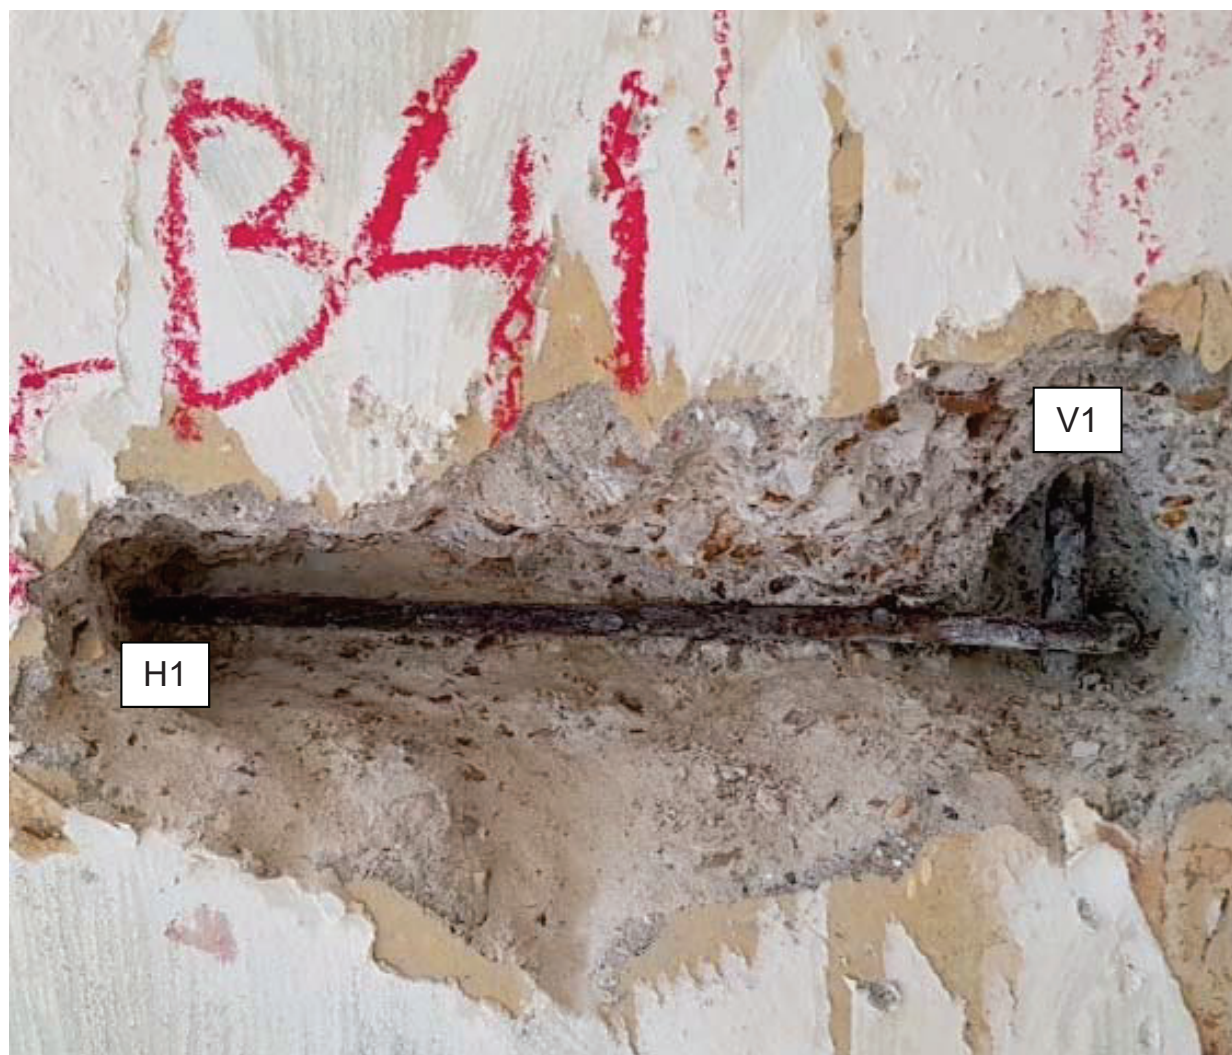
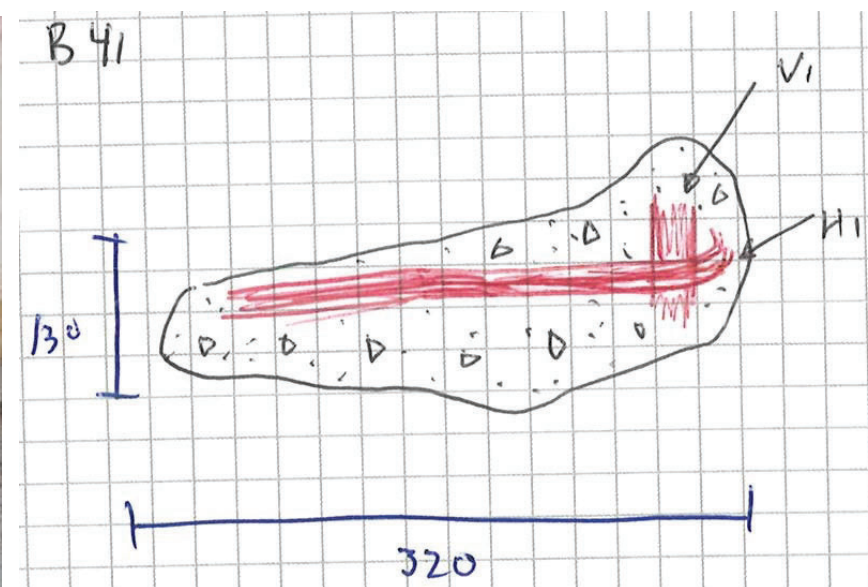
SITE	DETAILS	DATE	CONTRACT NO.	INITIALS	
Lannoy Building – Flat 12	Breakout B41 – Living Room Wall A	August 2018	SUR183482	MAH/PW/JI

B41	V1	H1
Bar Ø (mm)	12	10
Bar Type	Round, Smooth	Round, Smooth
Min. Cover (mm)	71	60
Condition	Good	Light Surface Corrosion

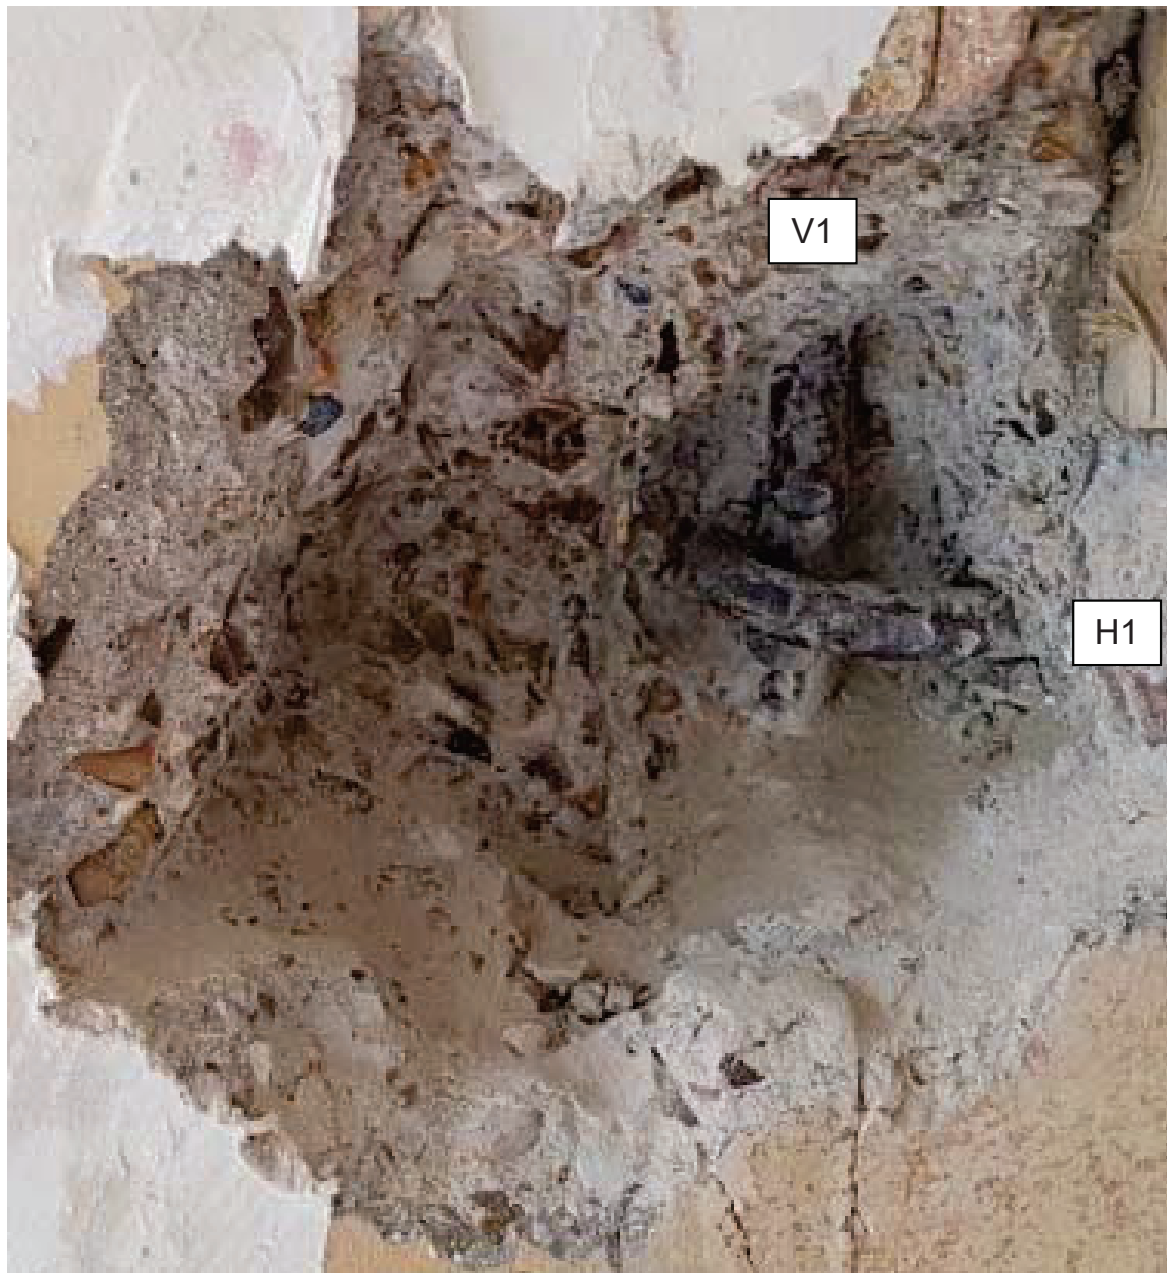
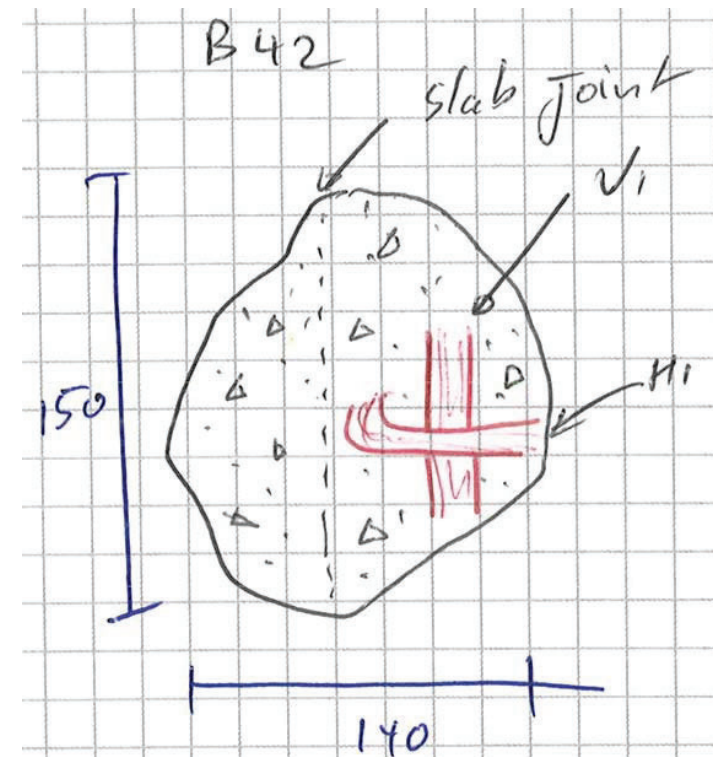
SITE	DETAILS	DATE	CONTRACT NO.	INITIALS	
Lannoy Building – Flat 12	Breakout B42 – Living Room Wall A	August 2018	SUR183482	MAH/PW/JI

B42	V1	H1
Bar Ø (mm)	12	10
Bar Type	Round, Smooth	Round, Smooth
Min. Cover (mm)	70	51
Condition	Good	Good

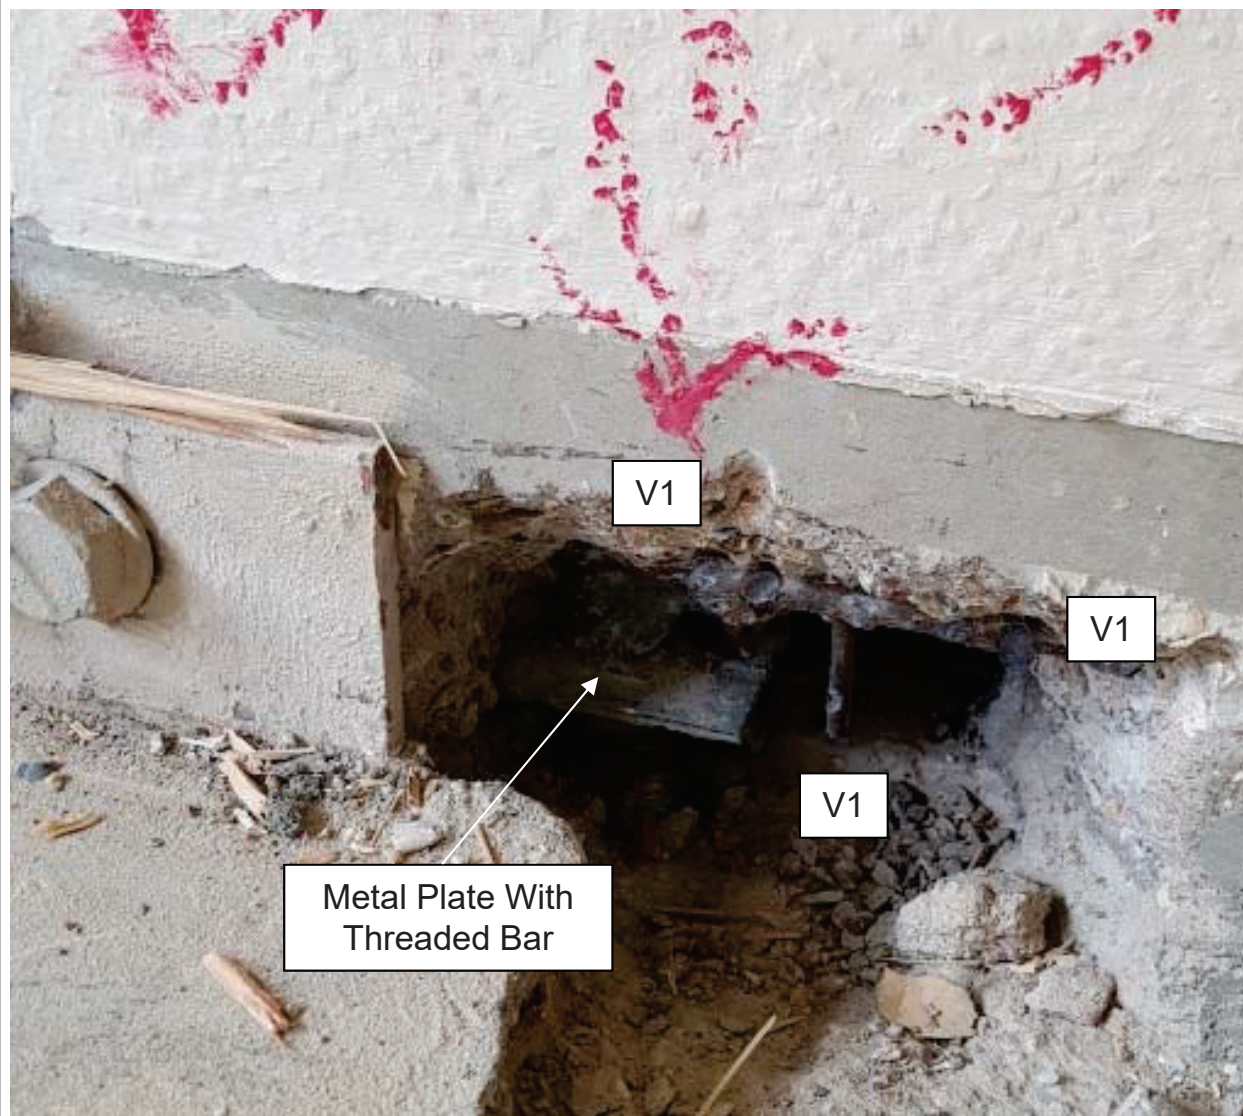
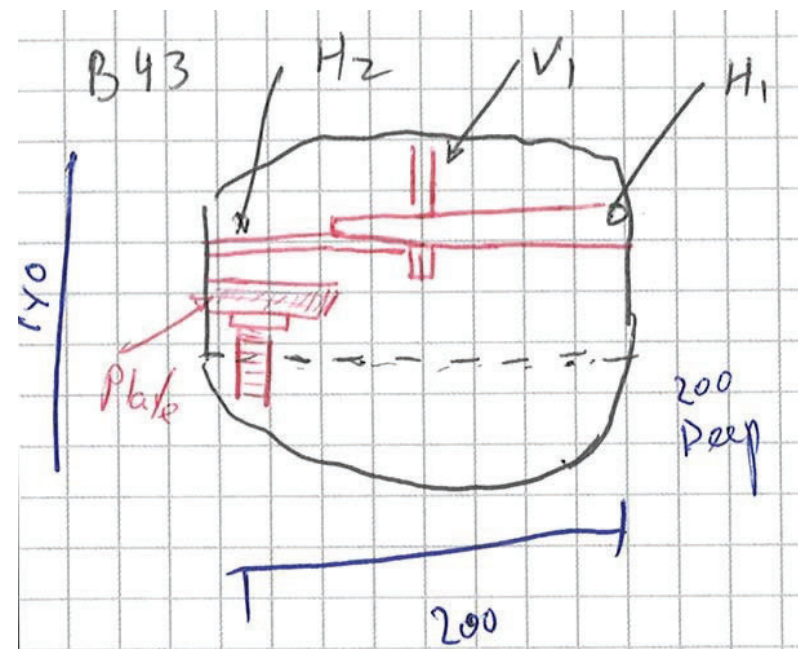
SITE	DETAILS	DATE	CONTRACT NO.	INITIALS	
Lannoy Building – Flat 12	Breakout B43 – Living Room Wall A	August 2018	SUR183482	MAH/PW/JI

B43	V1	H1	H2
Bar Ø (mm)	6	10	10
Bar Type	Round, Smooth	Round, Smooth	Round, Smooth
Min. Cover (mm)	42	30	48
Condition	Good	Good	Good

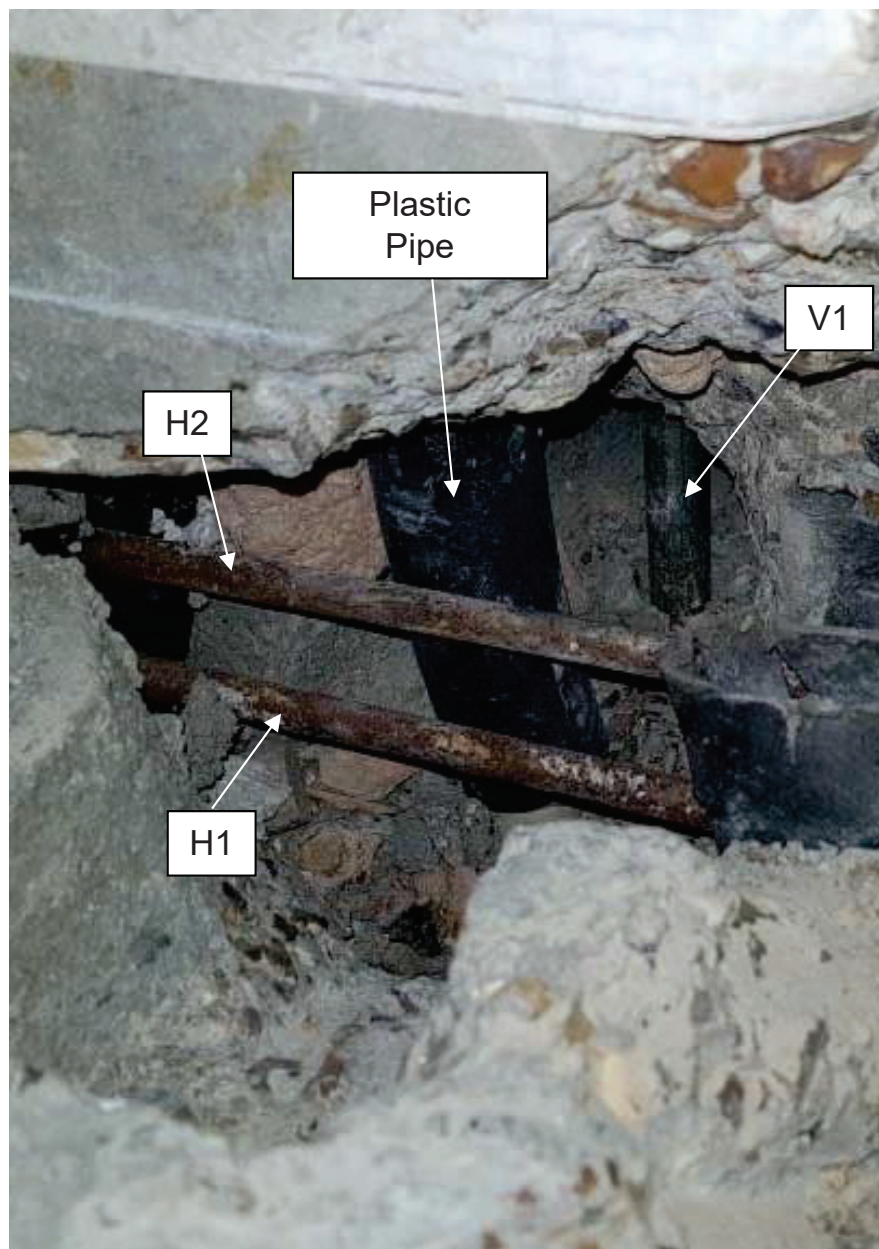
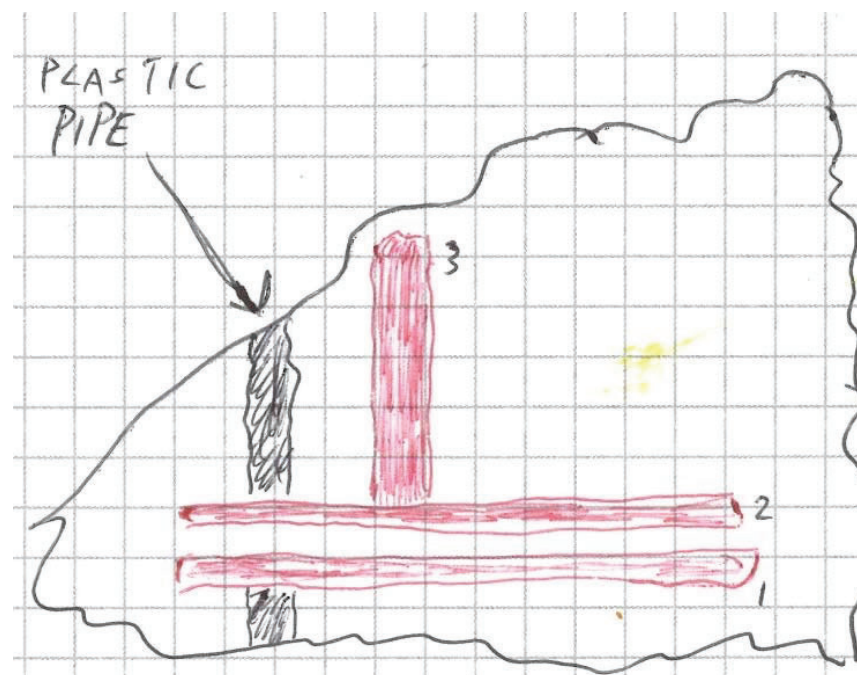
SITE	DETAILS	DATE	CONTRACT NO.	INITIALS	
Hartopp Building - Flat 35	Breakout B19 – Living Room Wall A	August 2018	SUR183482	MAH/PW/JI

B19	1	2	3
Bar Ø (mm)	8	8	14
Bar Type	Round, Smooth	Round, Smooth	Round, Smooth
Min. Cover (mm)	80	80	250
Condition	Light Surface Corrosion	Light Surface Corrosion	Light Surface Corrosion

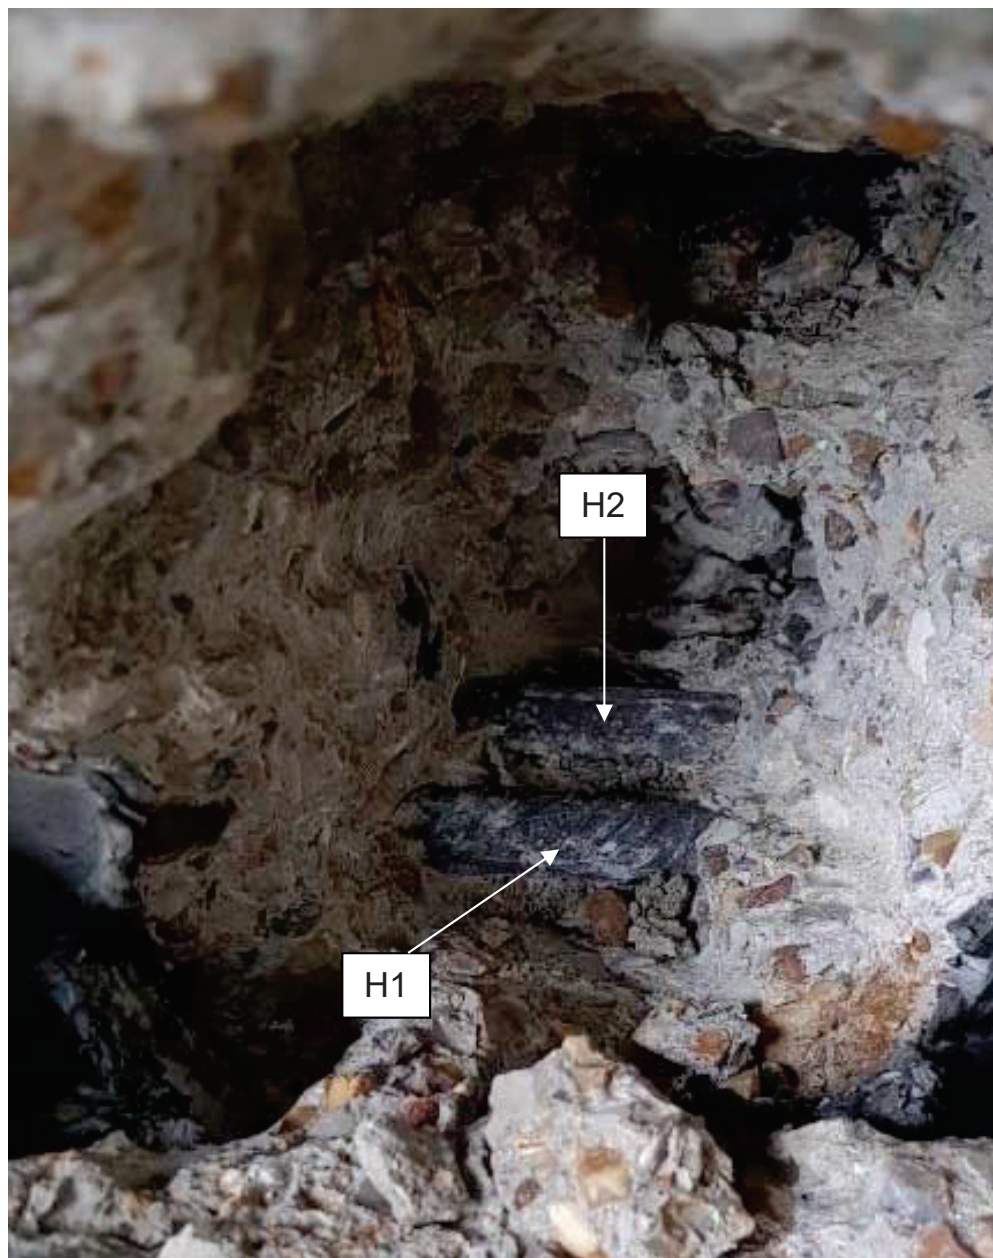
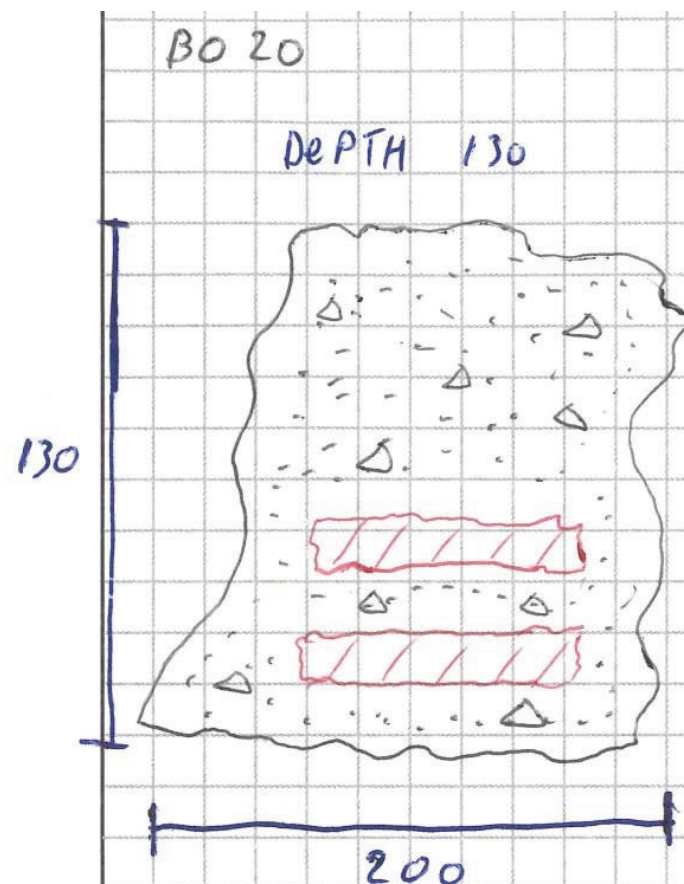
SITE	DETAILS	DATE	CONTRACT NO.	INITIALS	
Hartopp Building - Flat 35	Breakout B20 – Living Room Wall A	August 2018	SUR183482	MAH/PW/ JI

B20	1	2
Bar Ø (mm)	12	12
Bar Type	Round, Smooth	Round, Smooth
Min. Cover (mm)	55	55
Condition	Ribbed, Round	Ribbed, Round

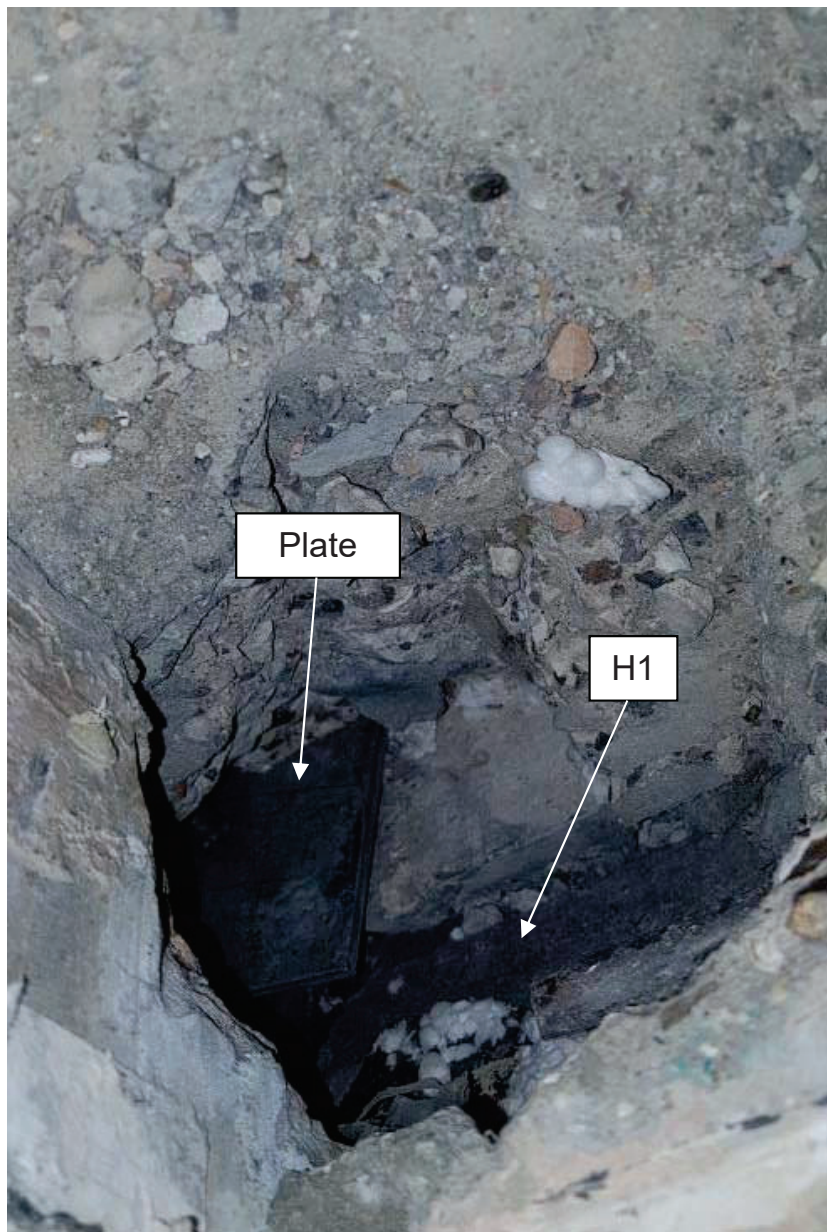
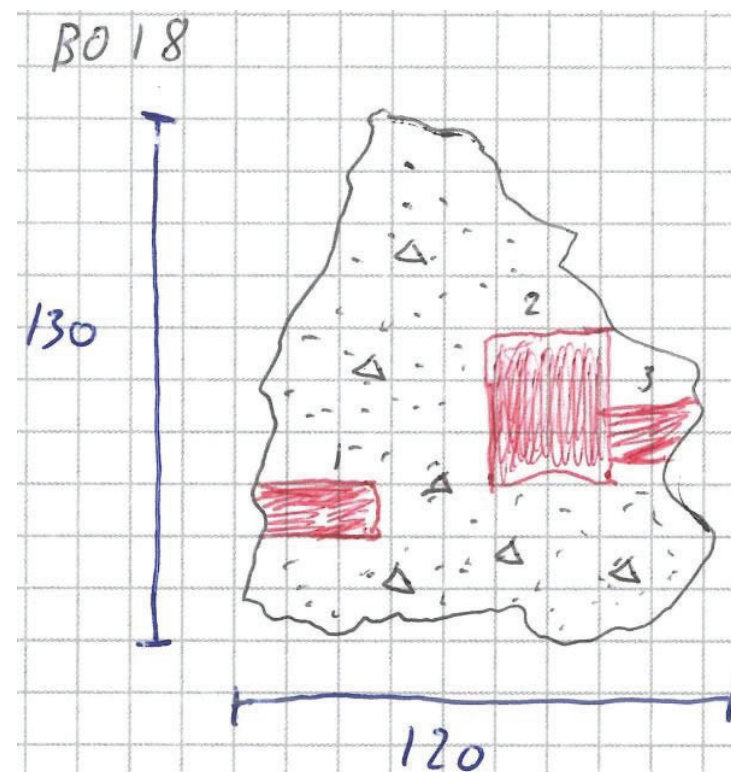
SITE	DETAILS	DATE	CONTRACT NO.	INITIALS	
Hartopp Building - Flat 35	Breakout B18 – Living Room Wall B	August 2018	SUR183482	MAH/PW/JI

B18	1	2	Plate 1
Bar Ø (mm)	10	8	6
Bar Type	Round, Smooth	Round, Smooth	6mm Thick Plate
Min. Cover (mm)	33	90	120
Condition	Good	Good	Good

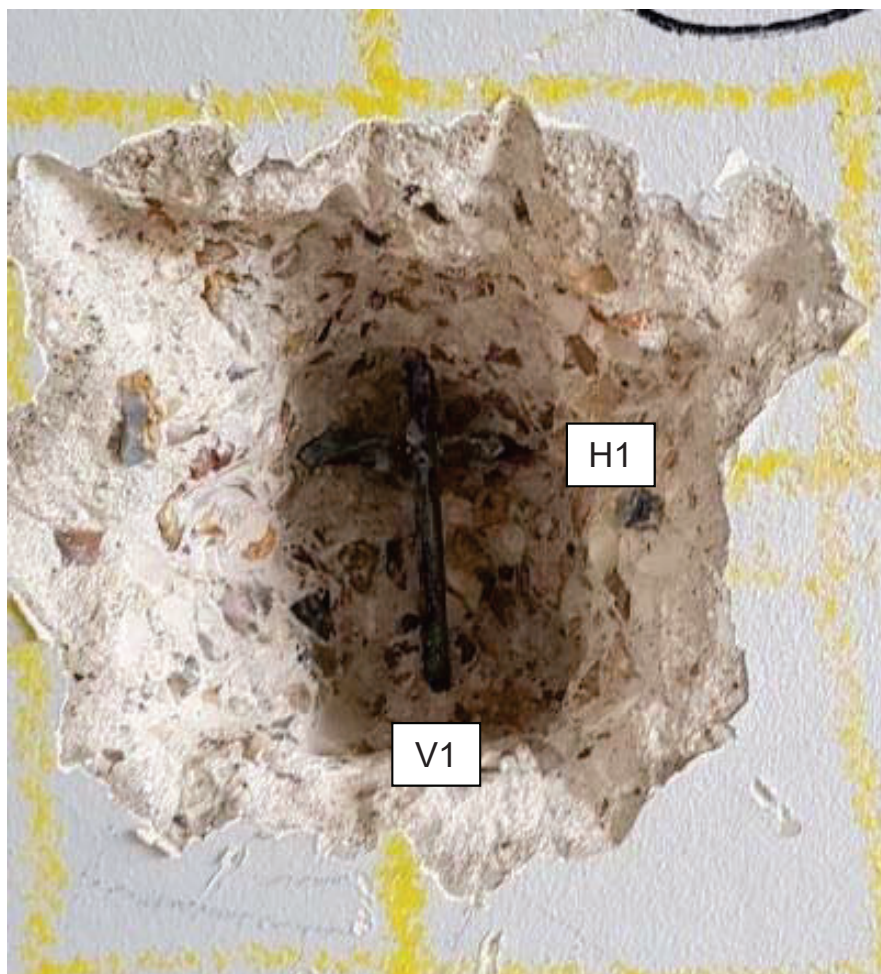
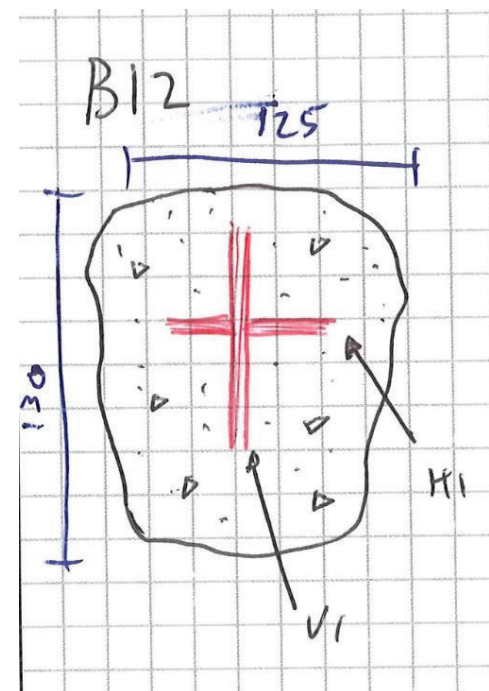
SITE	DETAILS	DATE	CONTRACT NO.	INITIALS	
Hartopp Building - Flat 35	Breakout B12 – Living Room Wall C	August 2018	SUR183482	MAH/PW/ JI

B12	V1	H1
Bar Ø (mm)	6	6
Bar Type	Round, Smooth	Round, Smooth
Min. Cover (mm)	72	77
Condition	Good	Good

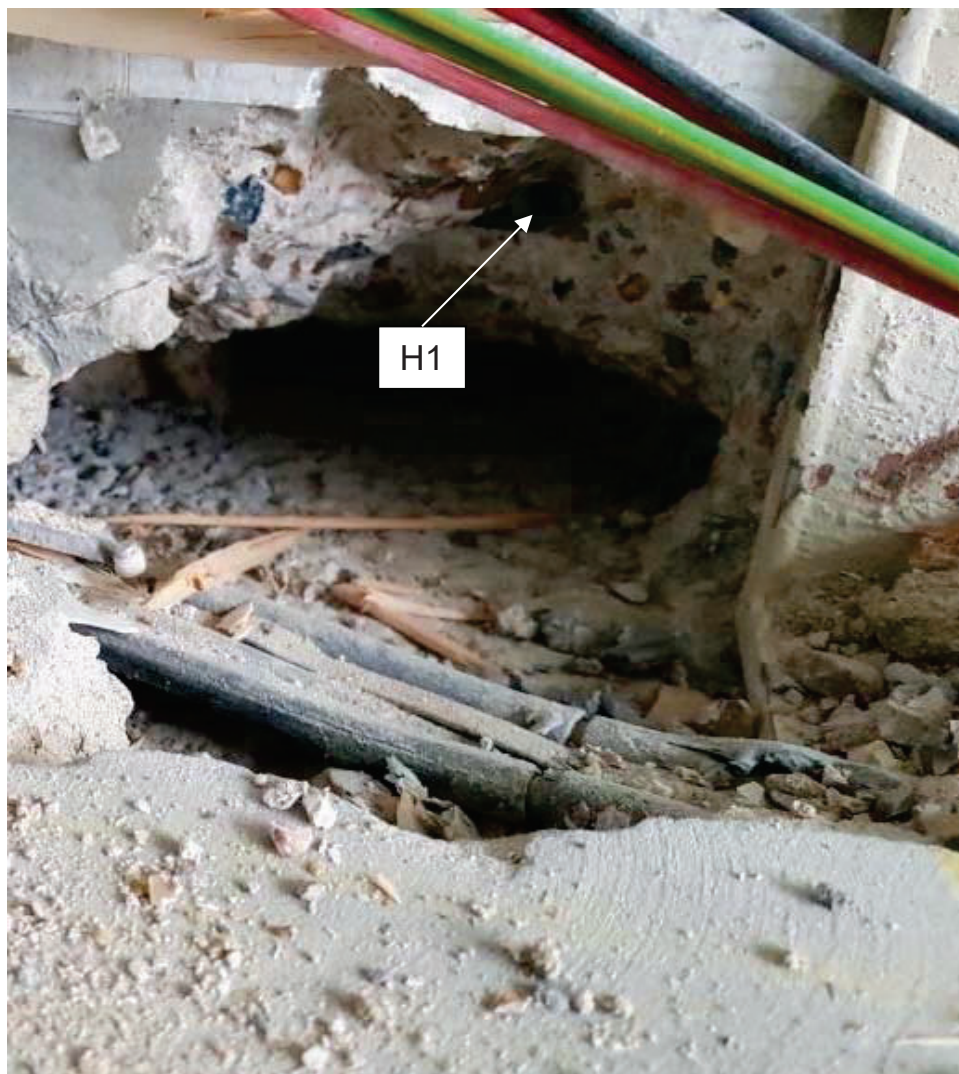
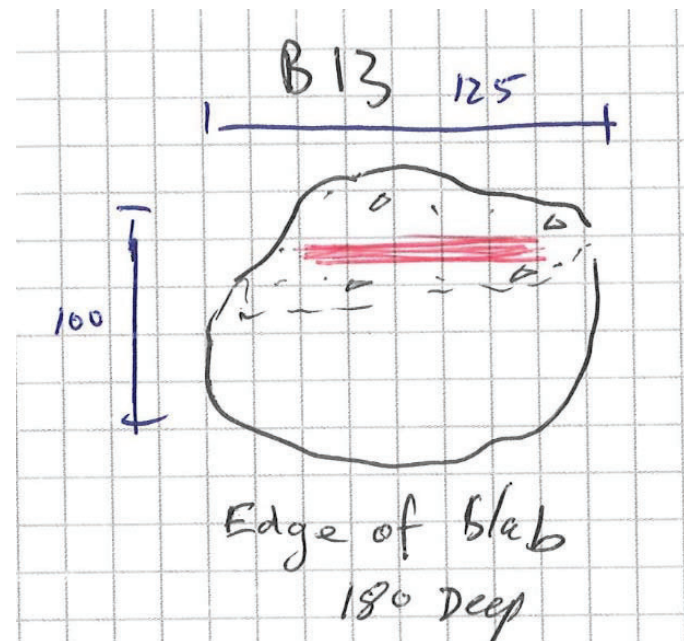
Hartopp Building - Flat 35	Breakout B13 – Living Room Wall C	August 2018	SUR183482	MAH/PW/ JI

B13	H1
Bar Ø (mm)	10
Bar Type	Round, Smooth
Min. Cover (mm)	41
Condition	Good

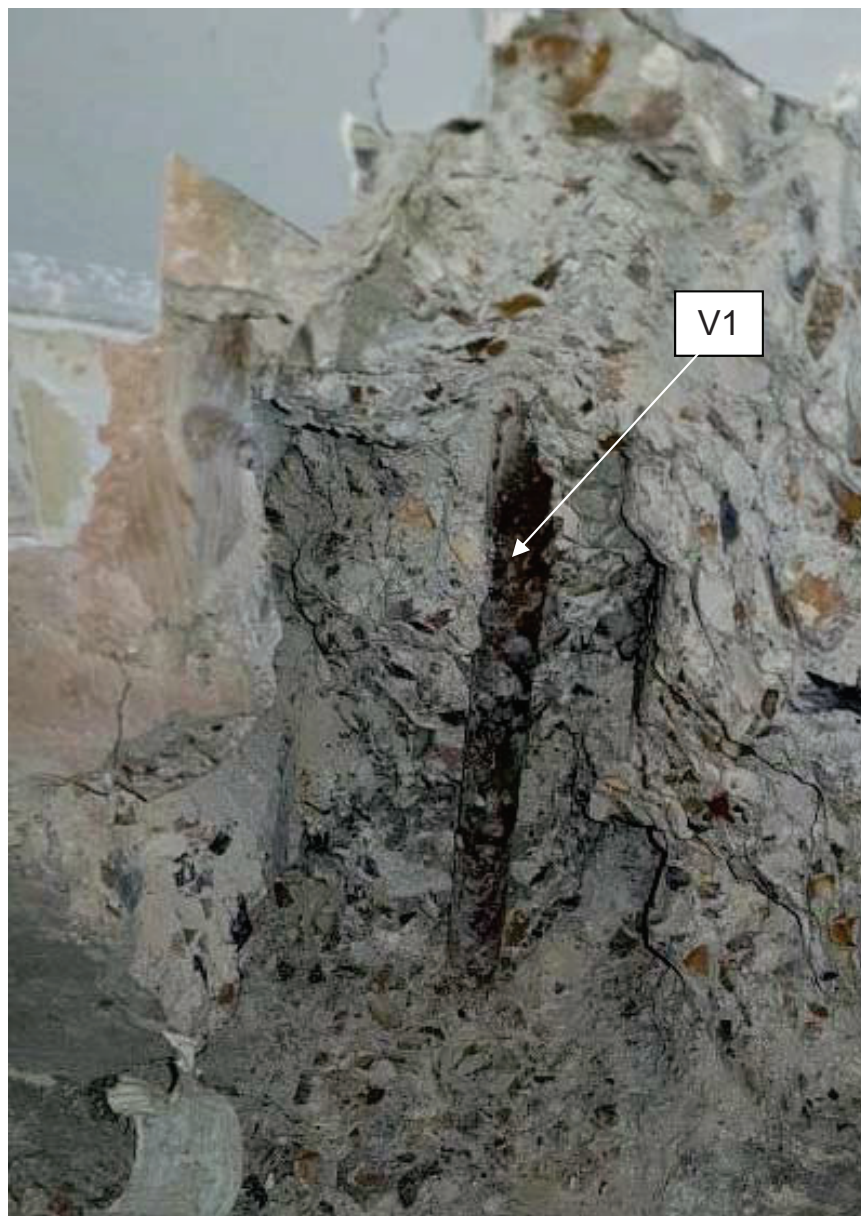
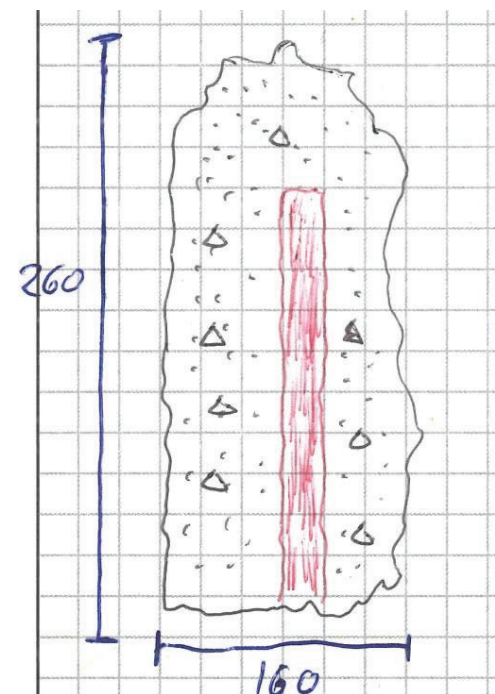
SITE	DETAILS	DATE	CONTRACT NO.	INITIALS	
Hartopp Building - Flat 35	Breakout B23 – Living Room Wall C	August 2018	SUR183482	MAH/PW/ JI

B23	1
<i>Bar Ø (mm)</i>	12
<i>Bar Type</i>	Round, Smooth
<i>Min. Cover (mm)</i>	62
<i>Condition</i>	Light Surface Corrosio n

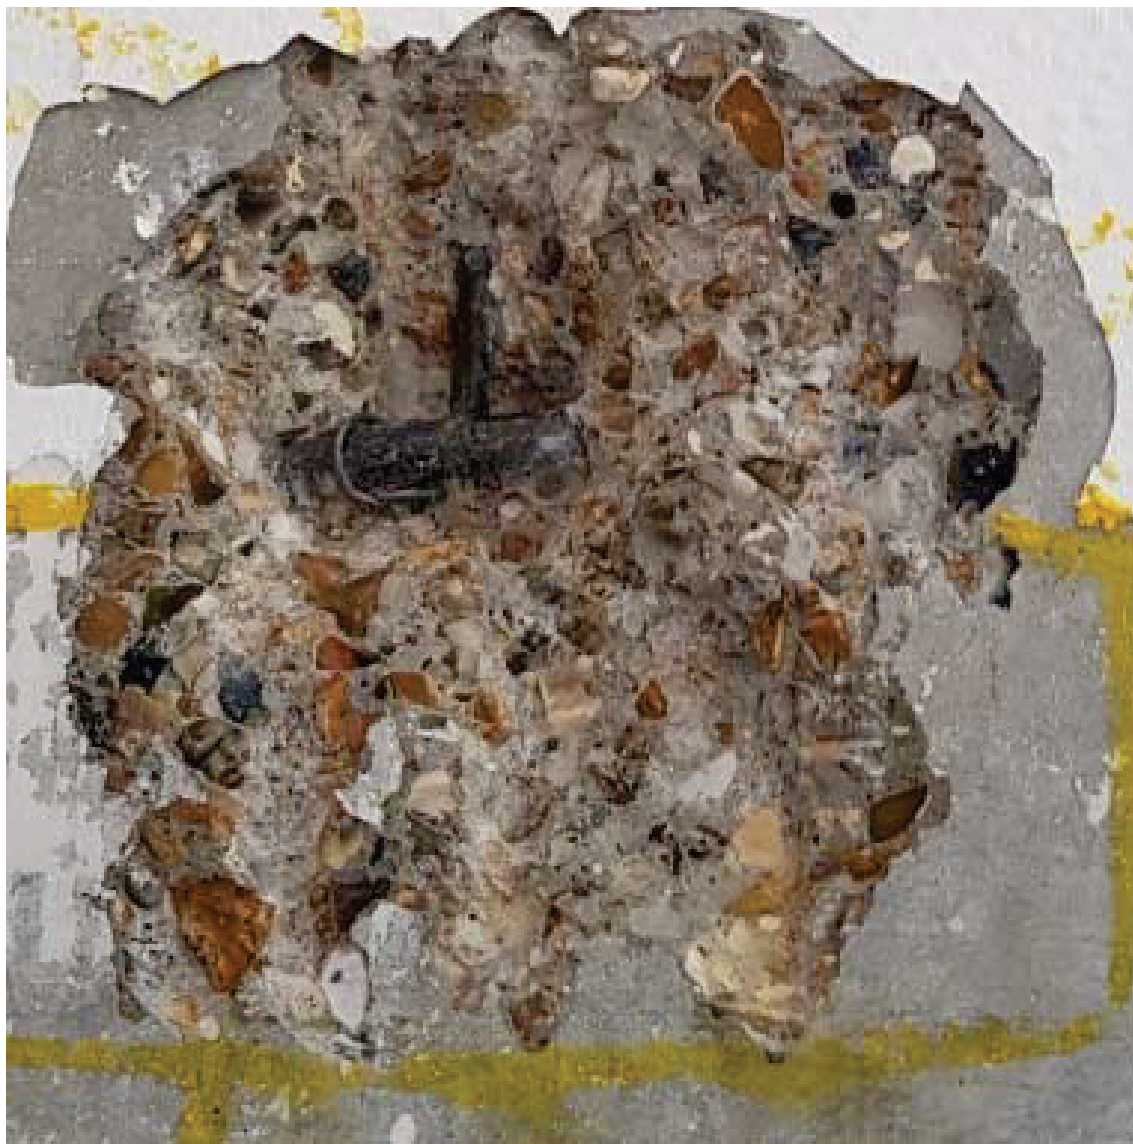
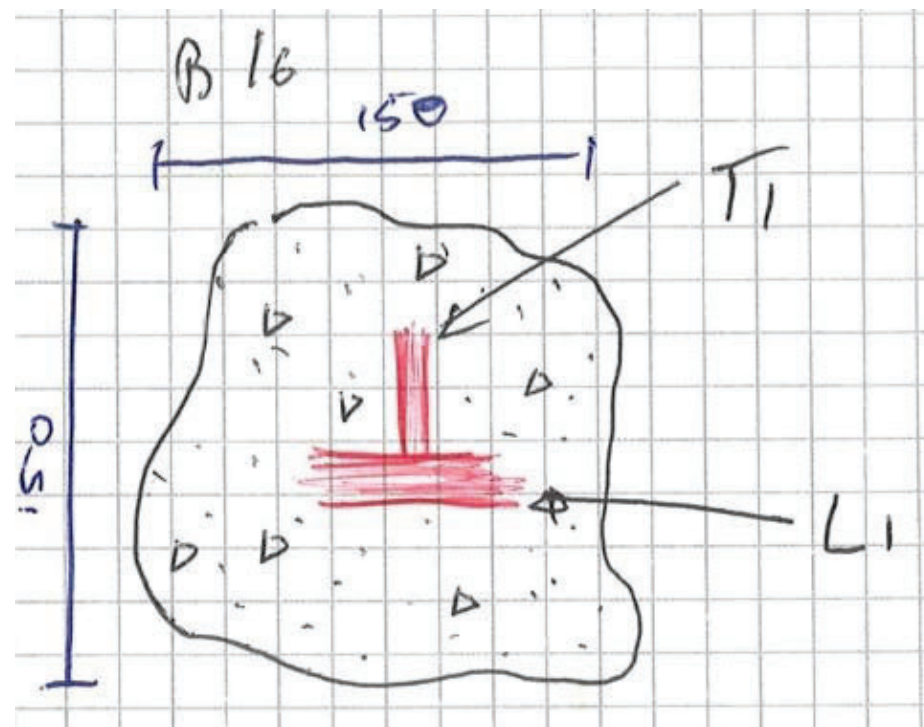
SITE	DETAILS	DATE	CONTRACT NO.	INITIALS	
Hartopp Building - Flat 35	Breakout B16 – Living Room Soffit	August 2018	SUR183482	MAH/PW/ JI

B16	L1	T1
Bar Ø (mm)	12	6
Bar Type	Round, Smooth	Round, Smooth
Min. Cover (mm)	18	31
Condition	Good	Good

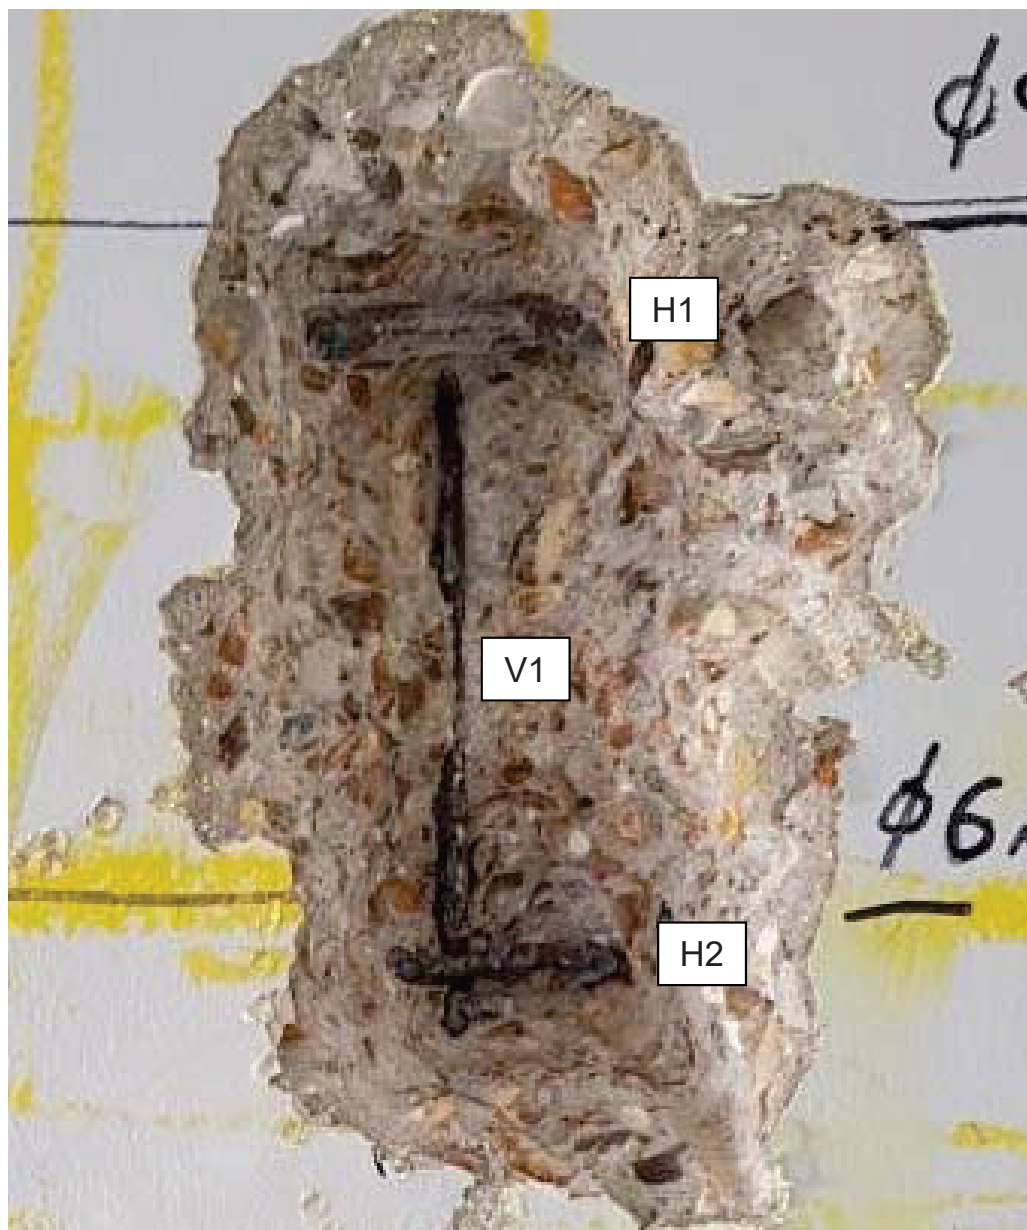
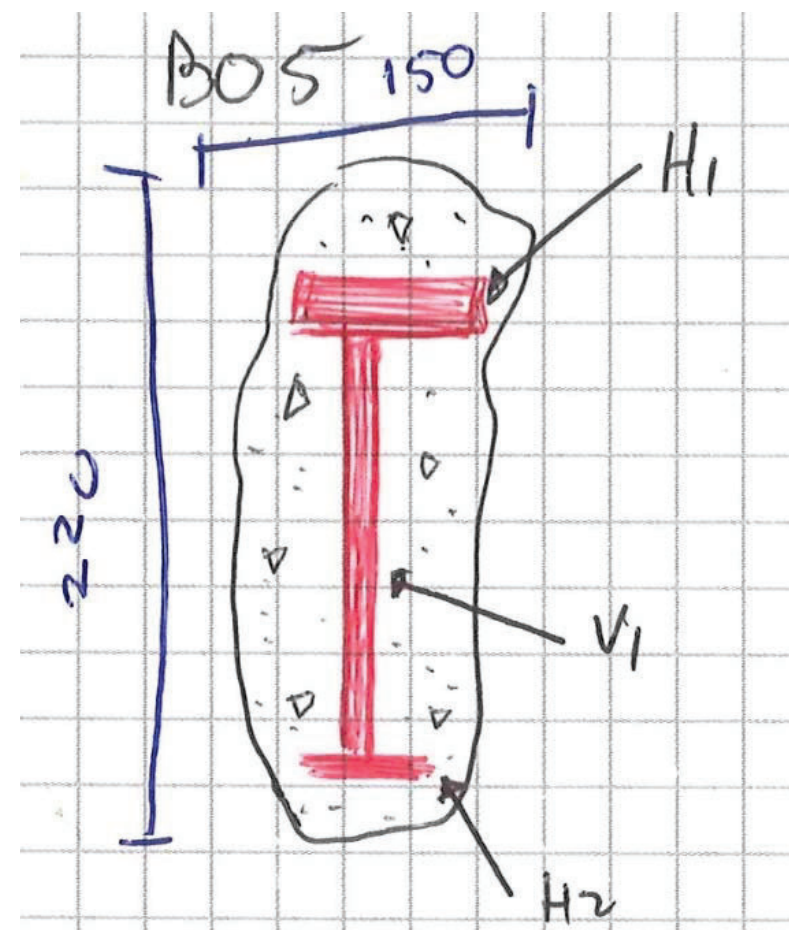
SITE	DETAILS	DATE	CONTRACT NO.	INITIALS	
Hartopp Building - Flat 35	Breakout B05 – Bed Room 2 Wall A	August 2018	SUR183482	MAH/PW/JI

B05	H1	H2	V1
Bar Ø (mm)	10	6	6
Bar Type	Round, Smooth	Round, Smooth	Round, Smooth
Min. Cover (mm)	33	48	55
Condition	Good	Good	Good

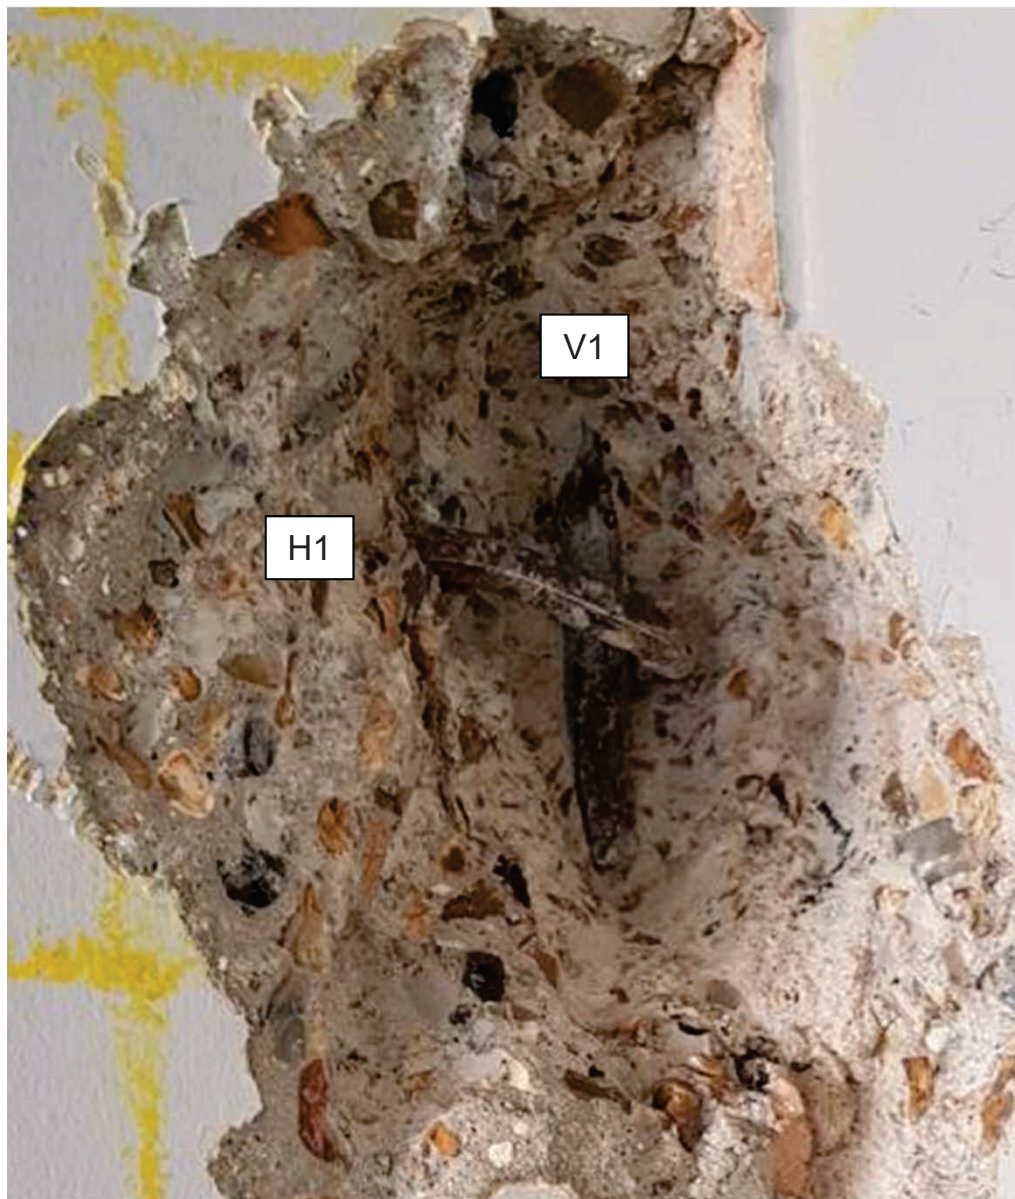
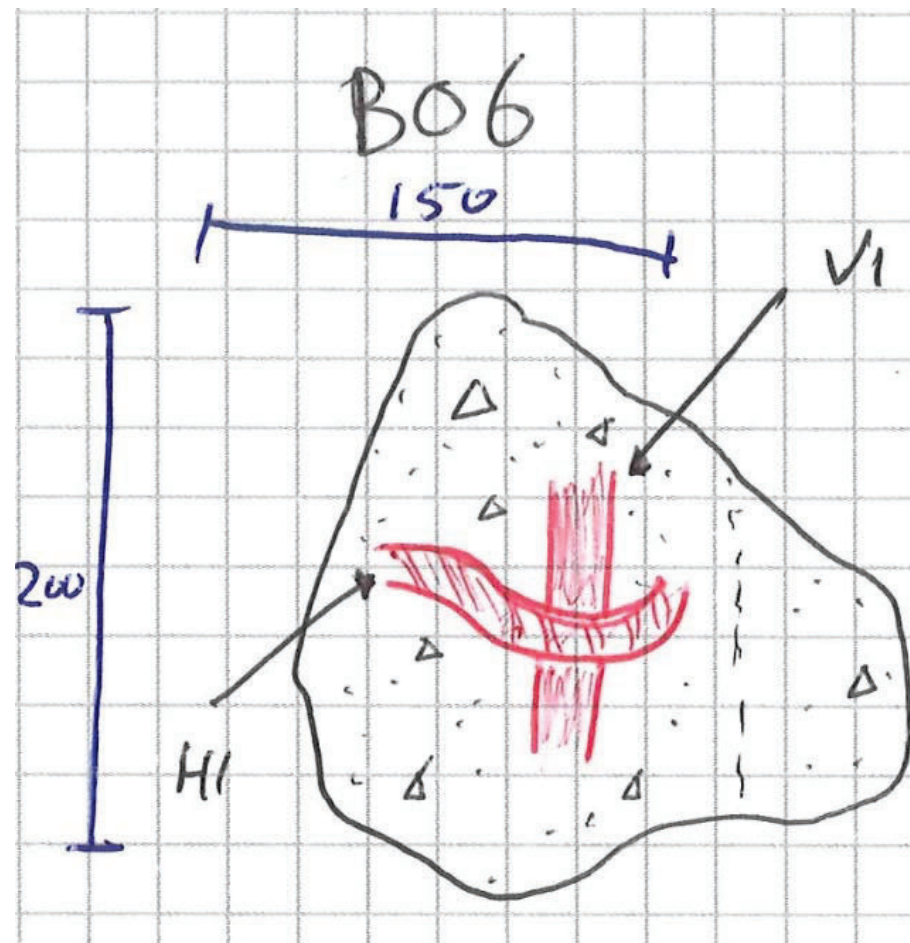
SITE	DETAILS	DATE	CONTRACT NO.	INITIALS	
Hartopp Building - Flat 35	Breakout B06 – Bed Room 2 Wall A	August 2018	SUR183482	MAH/PW/ JI	  Structural and building assessment

B06	V1	H1
Bar Ø (mm)	14	10
Bar Type	Round, Smooth	Round, Ribbed
Min. Cover (mm)	82	49
Condition	Good	Good
