London Borough of Hammersmith &
Fulham

Hartopp Point & Lannoy Point
Structural Assessment

Issue 1 | 12 February 2019

Job number 259559-00

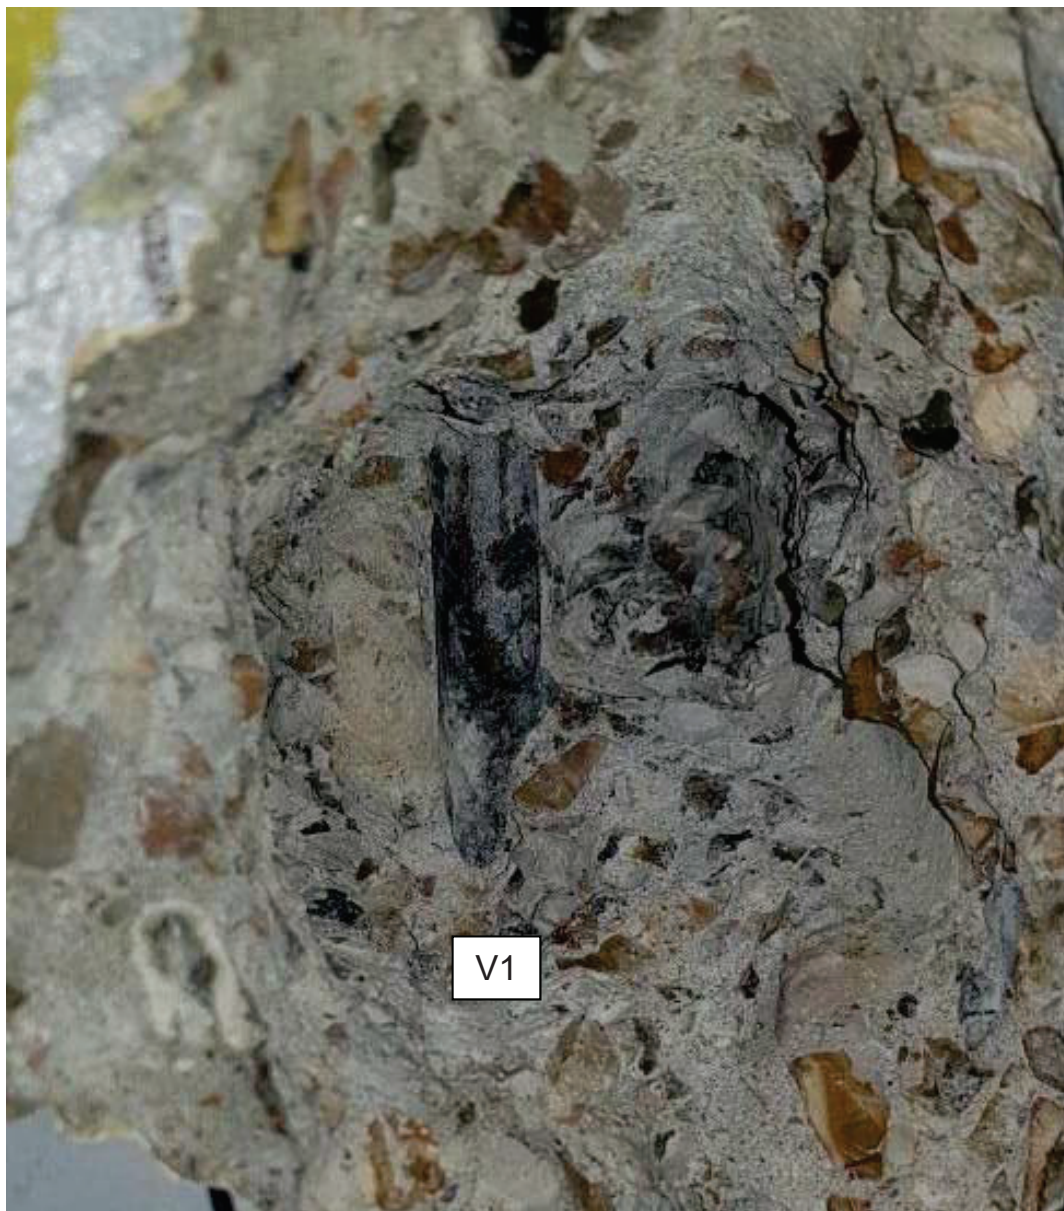
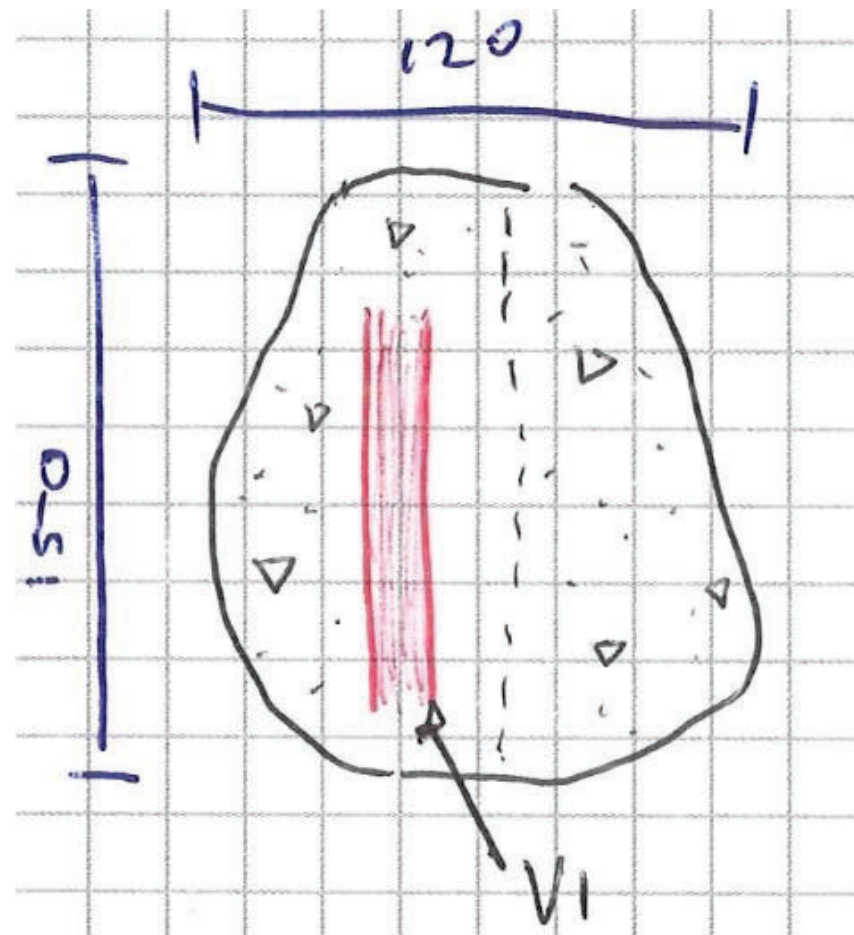
SITE	DETAILS	DATE	CONTRACT NO.	INITIALS	
Hartopp Building - Flat 35	Breakout B07 – Bed Room 2 Wall A	August 2018	SUR183482	MAH/PW/ JI

B07	V1
Bar Ø (mm)	14
Bar Type	Round, Smooth
Min. Cover (mm)	76
Condition	Good

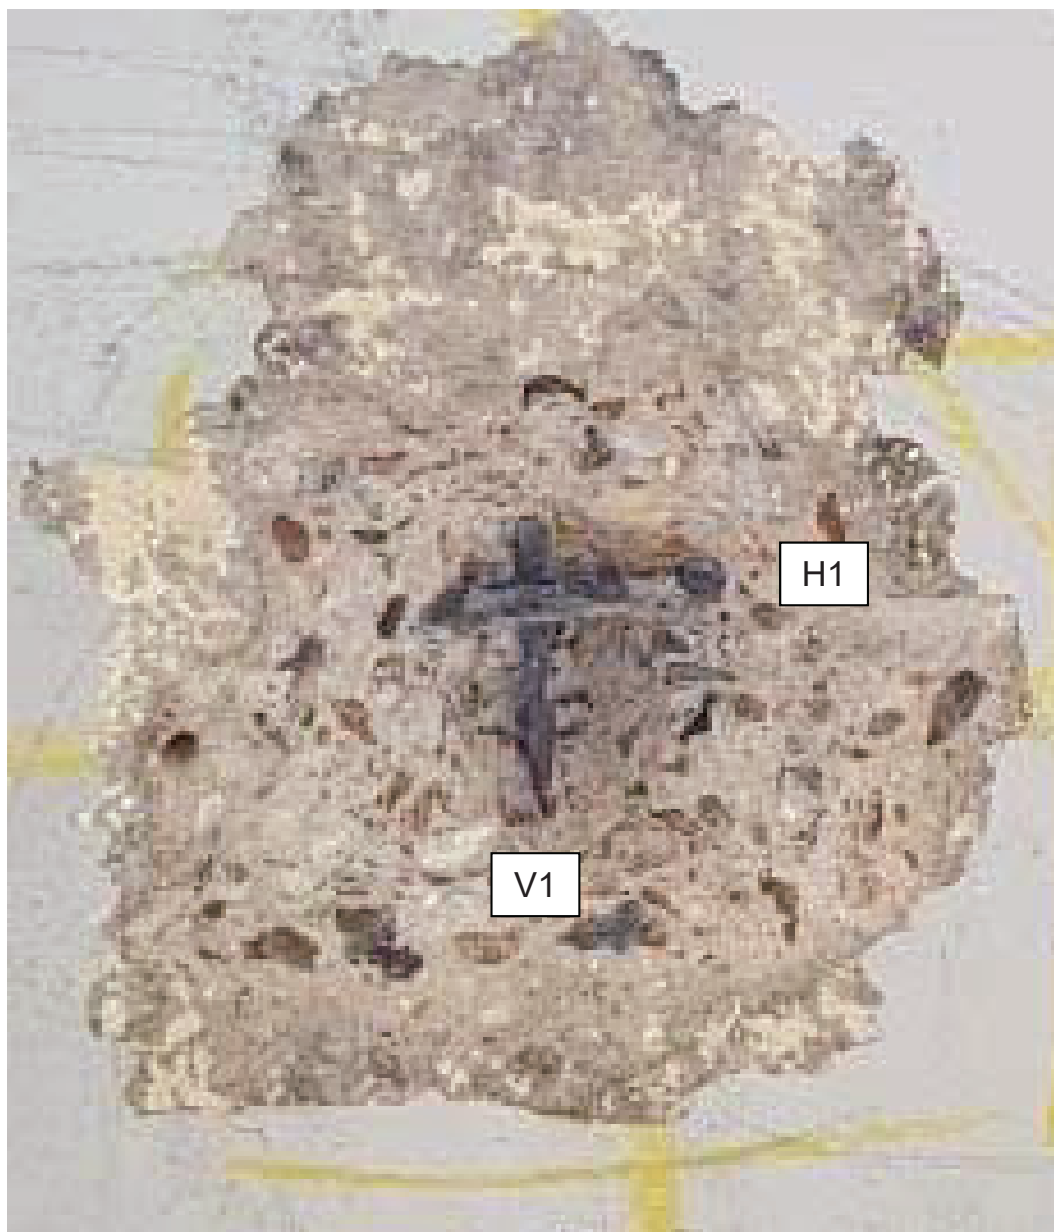
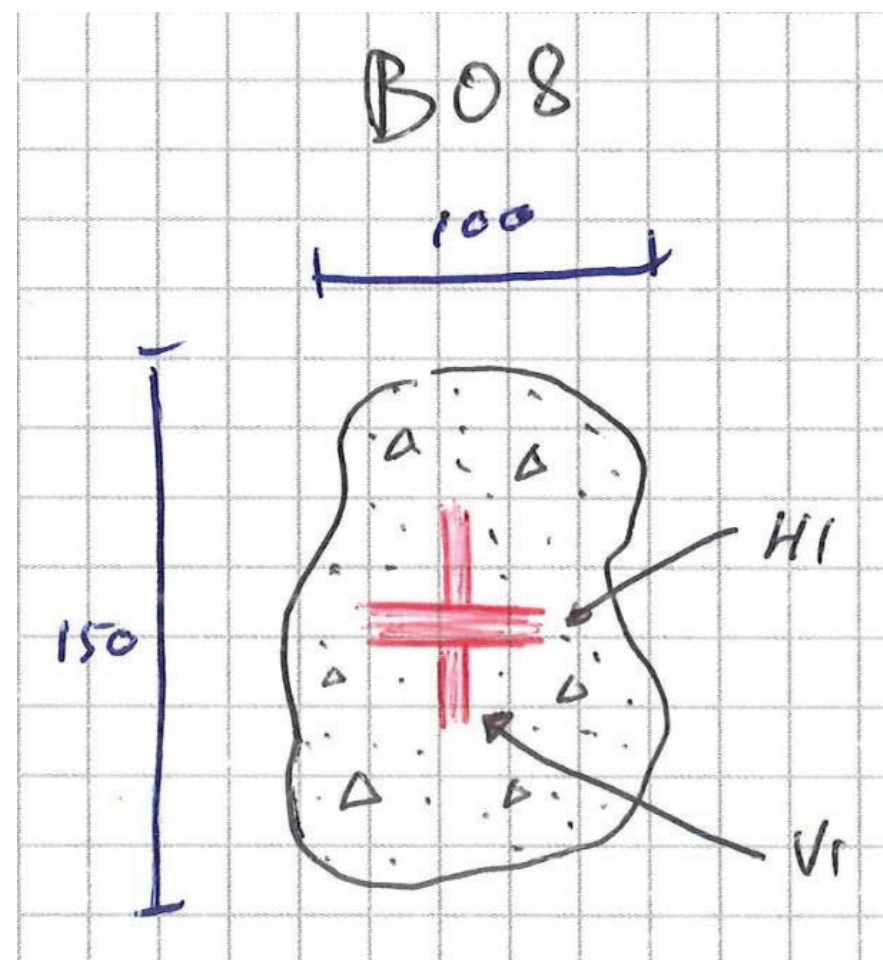
SITE	DETAILS	DATE	CONTRACT NO.	INITIALS	
Hartopp Building - Flat 35	Breakout B08 – Bed Room 2 Wall B	August 2018	SUR183482	MAH/PW/ JI	  Structural and building assessment

B08	V1	H1
Bar Ø (mm)	6	9
Bar Type	Round, Smooth	Round, Smooth
Min. Cover (mm)	43	36
Condition	Good	Good

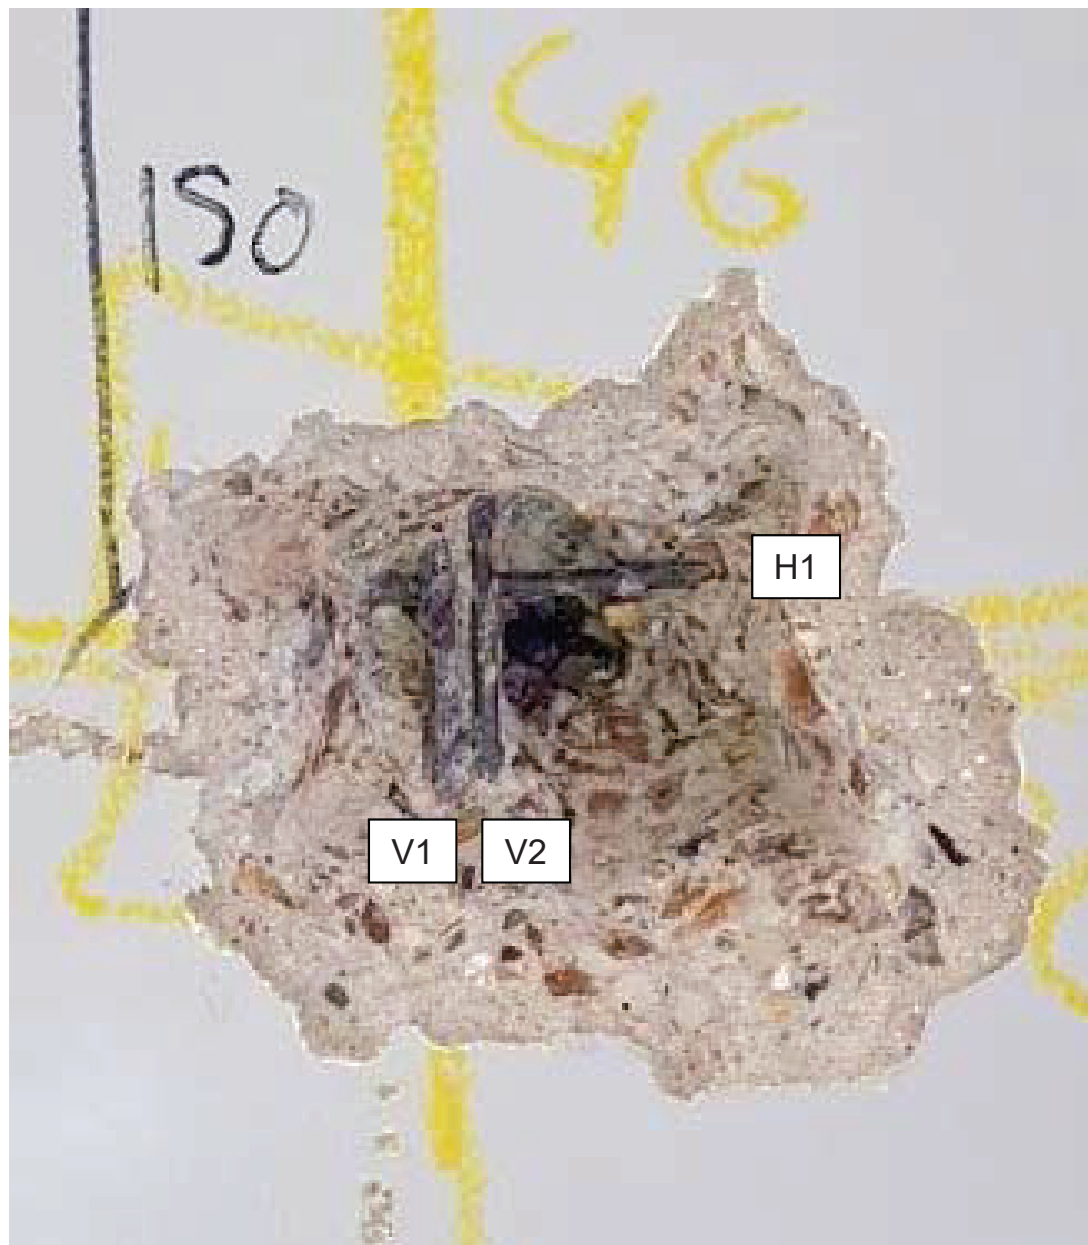
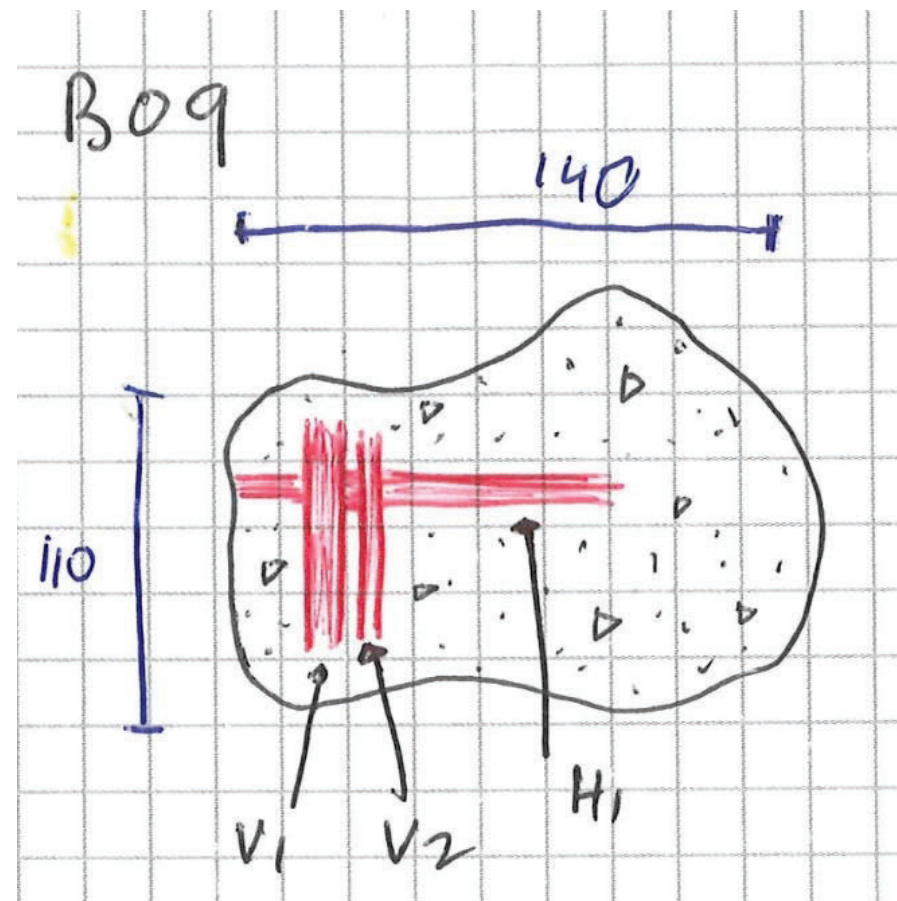
SITE	DETAILS	DATE	CONTRACT NO.	INITIALS	
Hartopp Building - Flat 35	Breakout B09 – Bed Room 2 Wall B	August 2018	SUR183482	MAH/PW/JI	  Structural and building assessment

B09	V1	V2	H1
Bar Ø (mm)	6	4	4
Bar Type	Round, Smooth	Round, Smooth	Round, Smooth
Min. Cover (mm)	46	48	53
Condition	Good	Good	Good

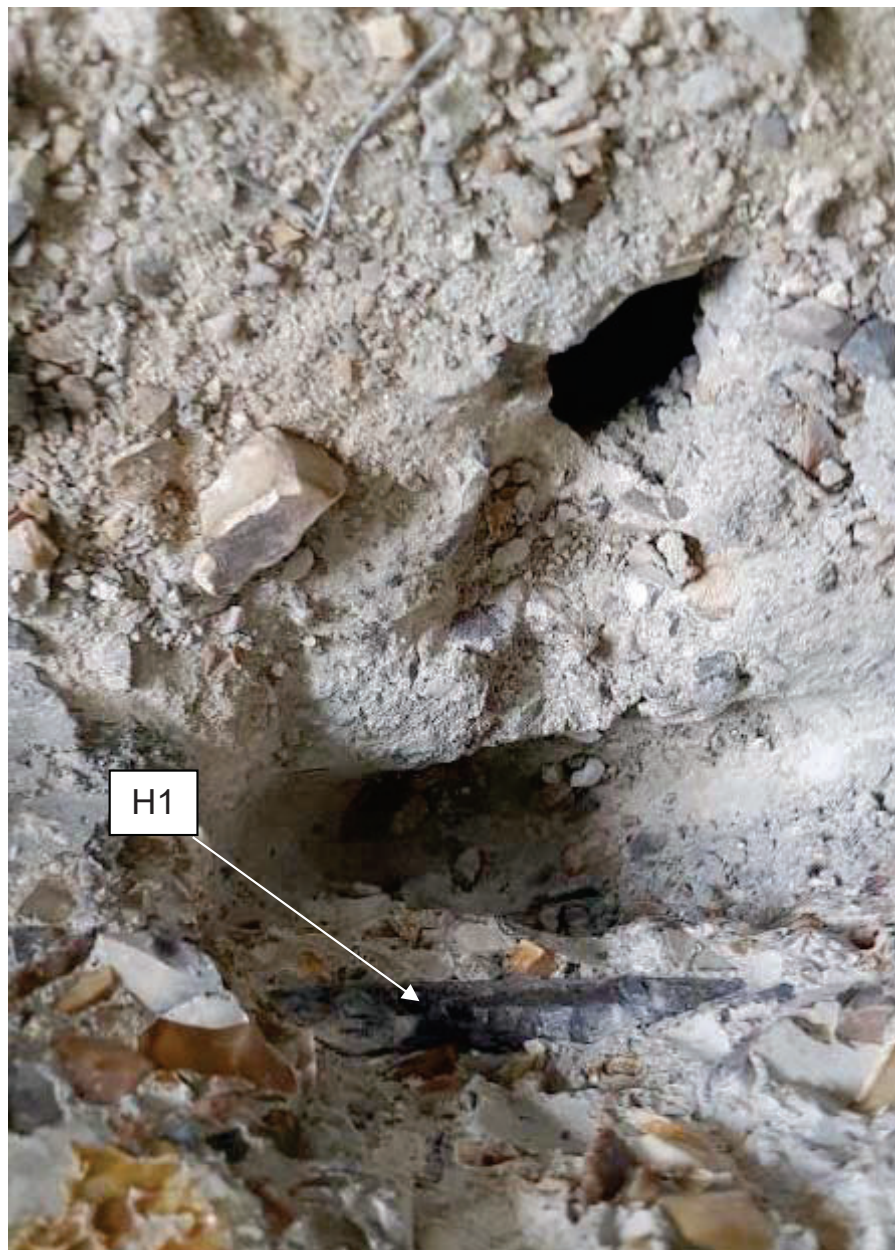
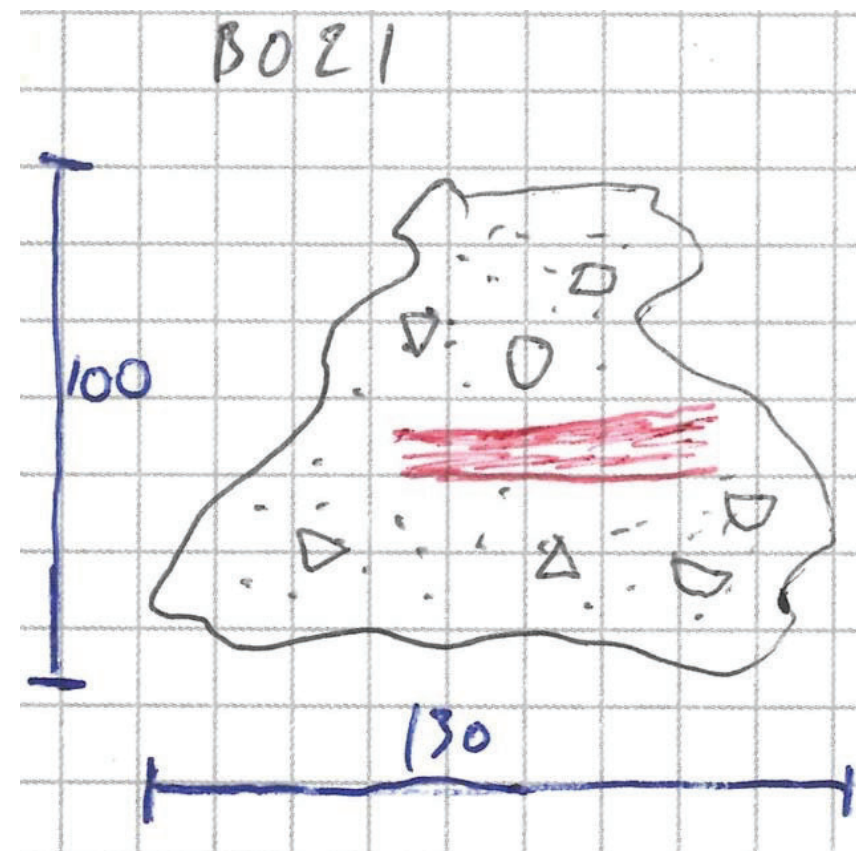
B21	1
<i>Bar Ø (mm)</i>	10
<i>Bar Type</i>	Round Smooth
<i>Min. Cover (mm)</i>	19
<i>Condition</i>	Good

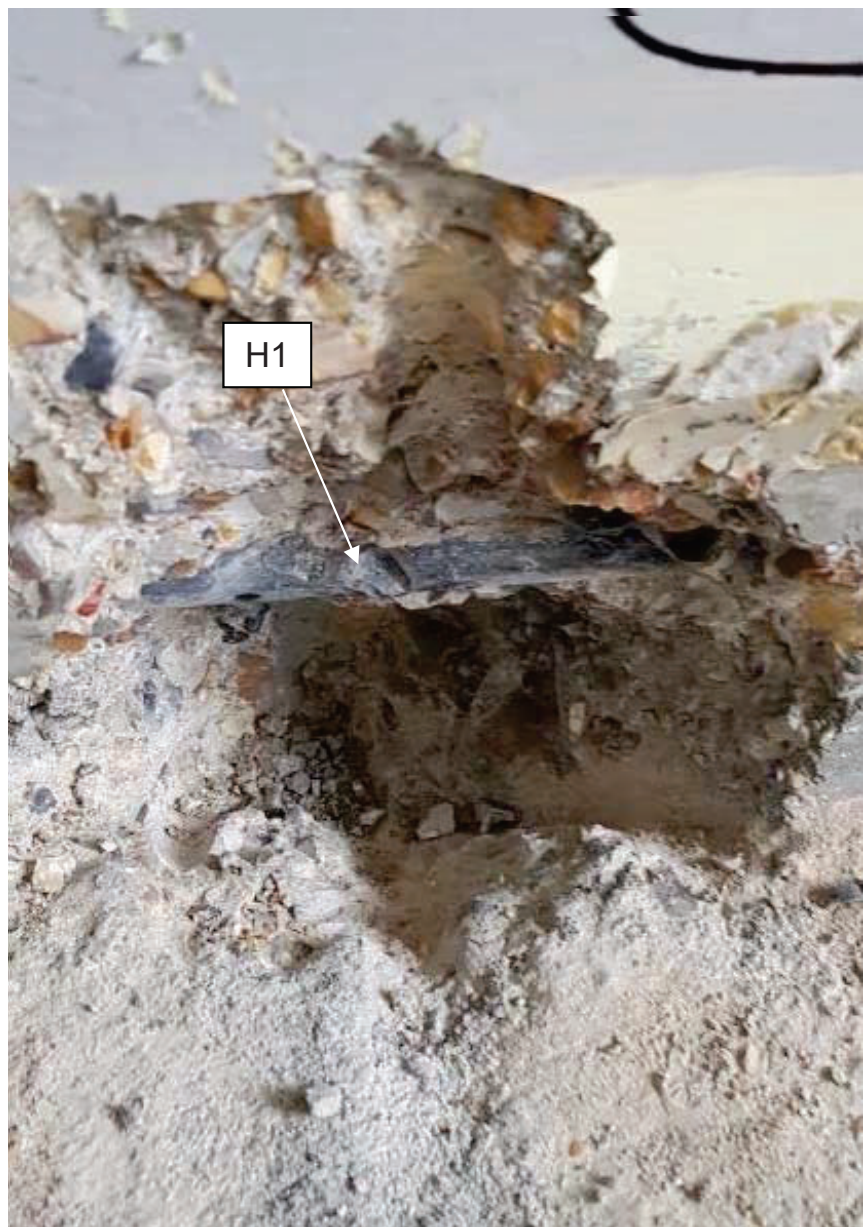
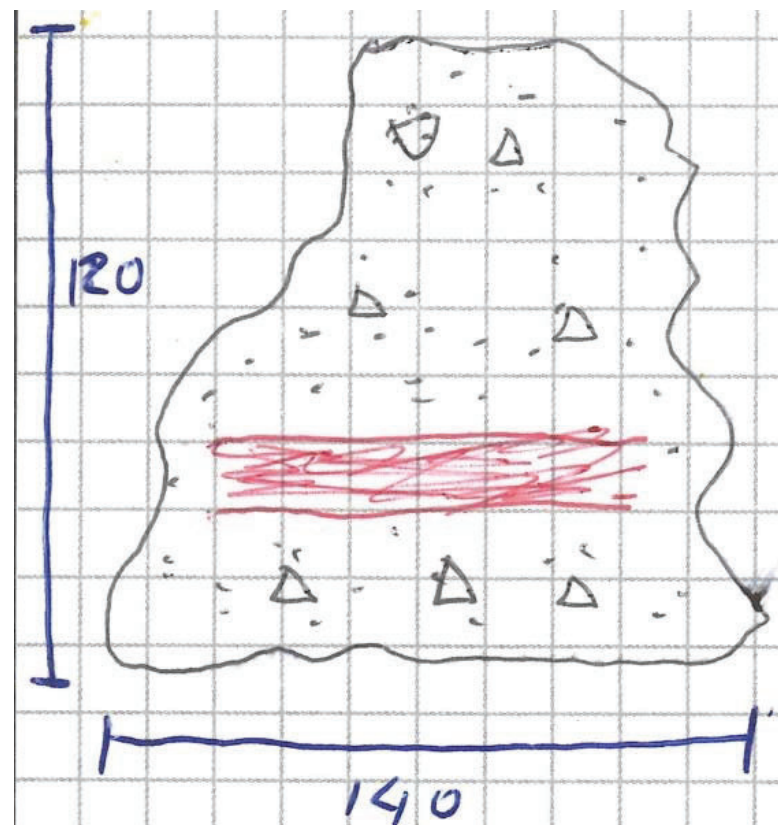
B22	1
<i>Bar Ø (mm)</i>	10
<i>Bar Type</i>	Round, Smooth
<i>Min. Cover (mm)</i>	18
<i>Condition</i>	Good

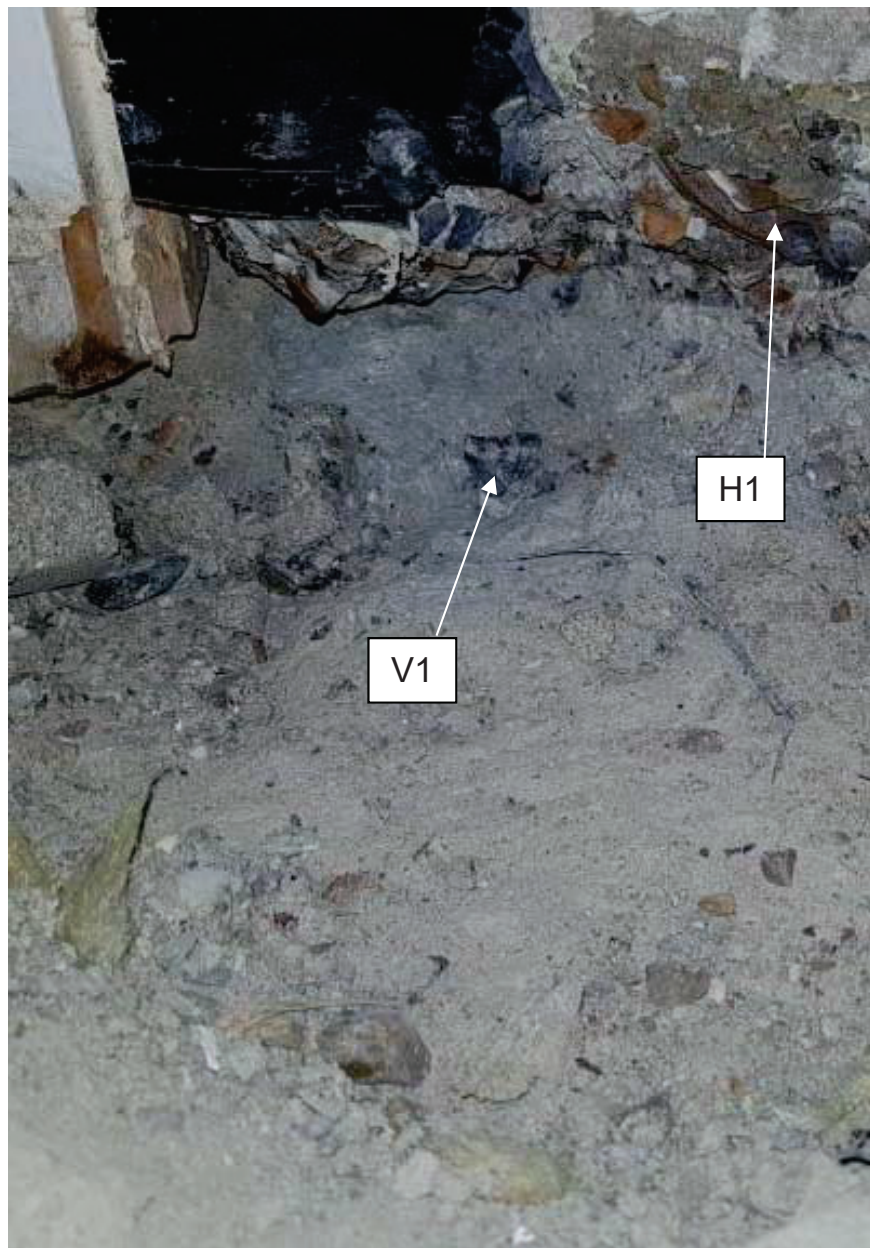
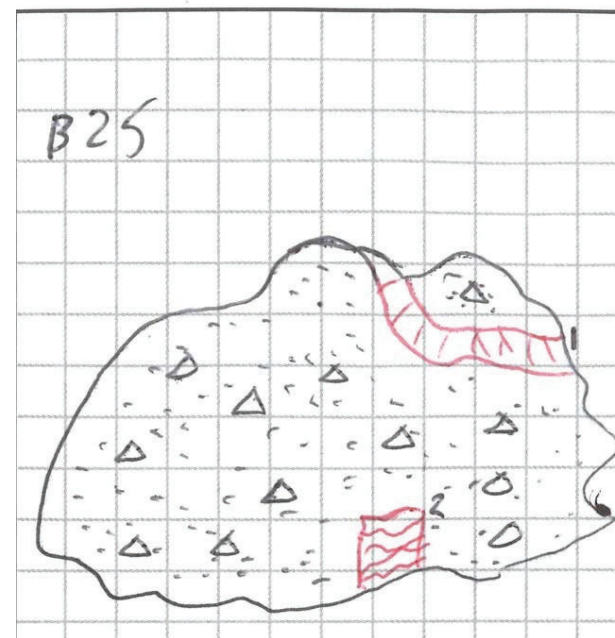
B25	1	2
Bar Ø (mm)	10	14
Bar Type	Ribbed, Round	Ribbed, Round
Min. Cover (mm)	9	25
Condition	Good	Good
