Hammersmith Bridge

Safe Operation of
Hammersmith Bridge

Issue 1

December 2020

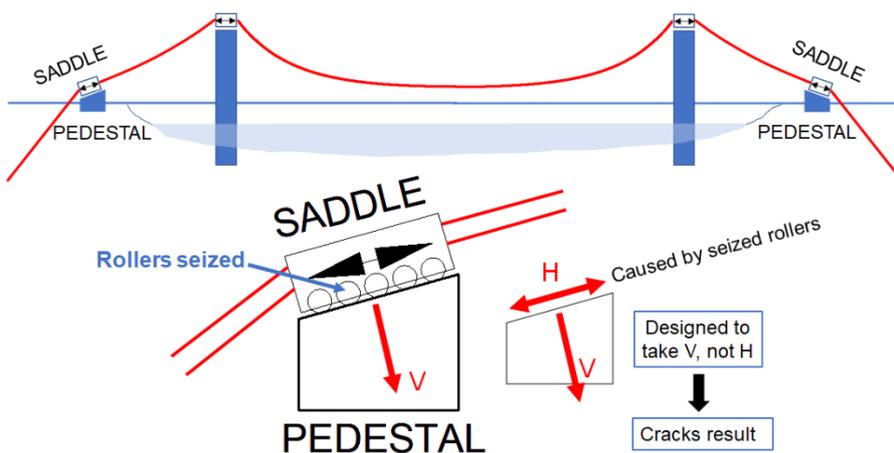
The problem is summarised in this diagram:

The suspension chains (red) are subjected to temperature changes which causes them to contract and expand. That movement is accommodated by rollers. Once the rollers seized, loads (H) were applied to the pedestals that they were not designed to take, and cracks in them resulted.

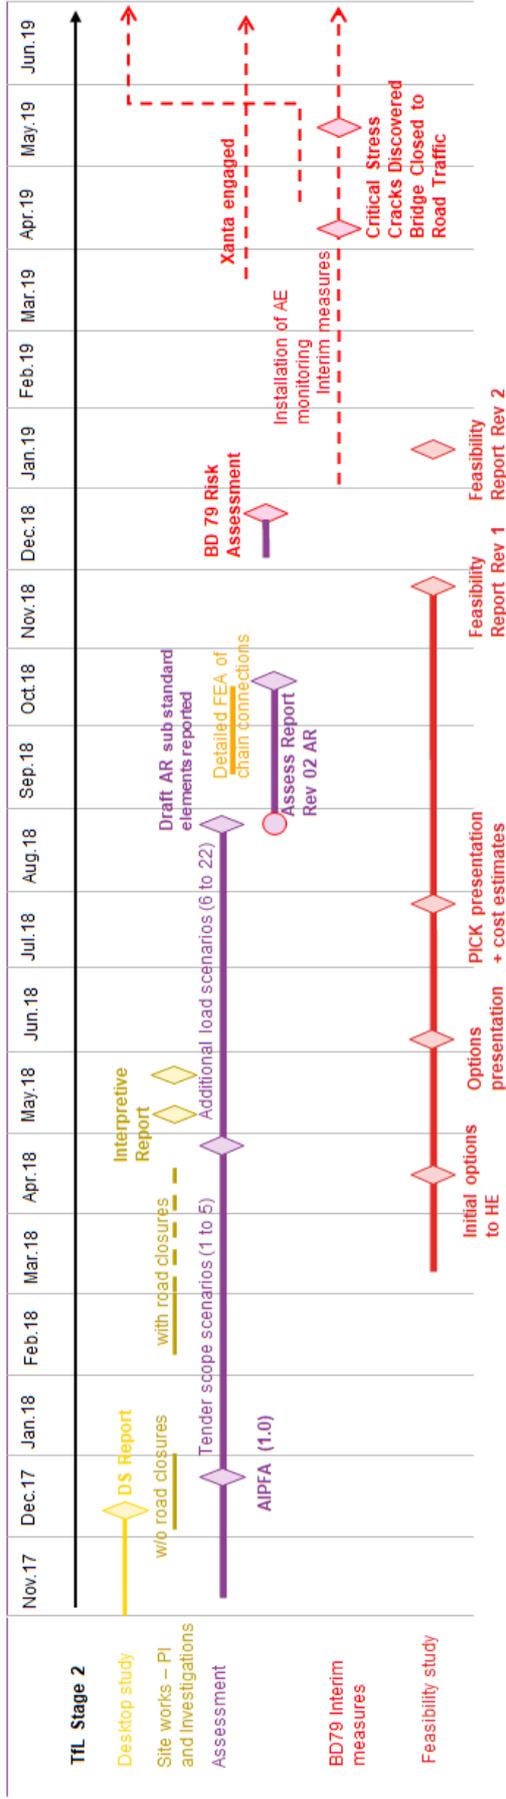
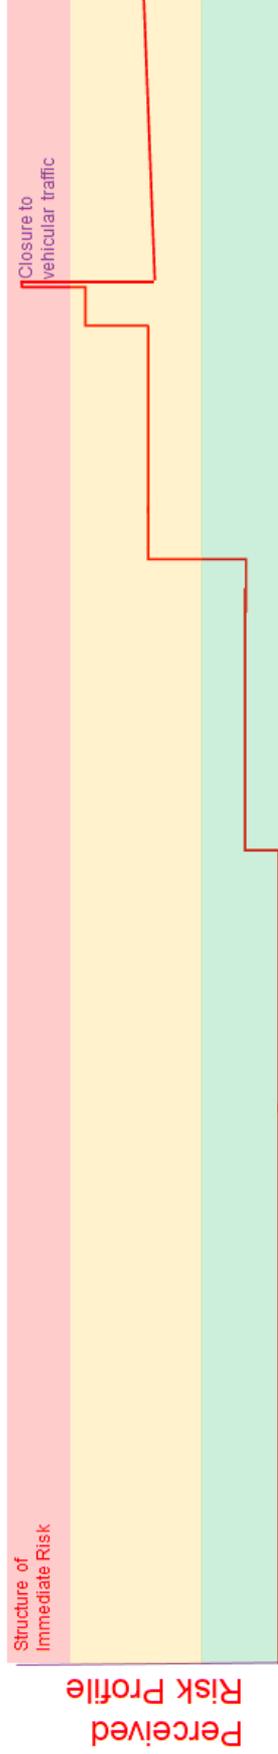
Timeline and Risk Profile

Annexed to this report is a timeline which details major events since 2017, which began with a clear expectation that the condition of the bridge was something that must be subjected to thorough analysis. The timeline is accompanied by an estimate of perceived safety risk associated with major events. This climbs with the passage of time leaving it as a “*structure of immediate risk*”, a self-explanatory term.
