HARTOPP & LANNOY HIGHRISE BUILDINGS

Structural Assessment of Hartopp and Lannoy Highrise Buildings Aintree Estate

STAGE (II) REPORT

Project No: 2017/01426/design 08 October 2018

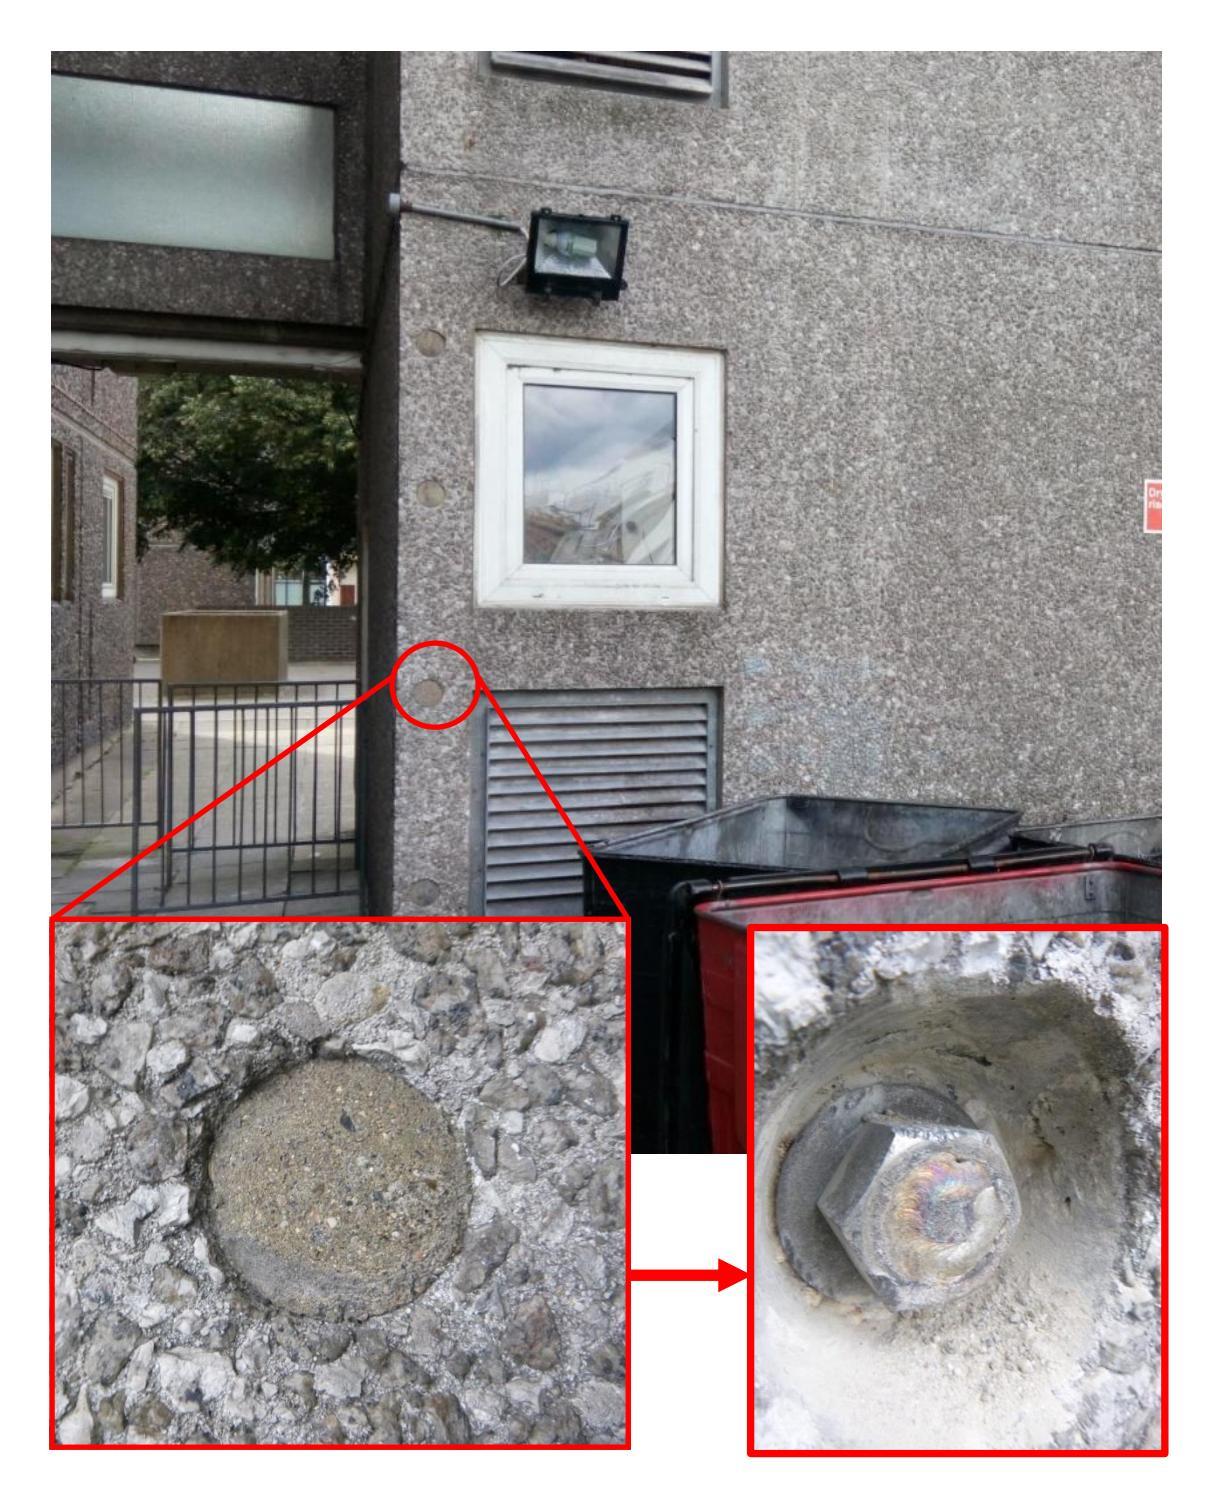
The intrusive investigation into the tower blocks uncovered no vertical wall ties as was expected of the system type. The only bolted wall panel connections observed were to the lift and stair access tower (Figures 4, 5 & 6). The bolts replace the reinforcement anchoring of the concrete panels together to provide the connectivity.

[Figure 4] Stair core bolted connection

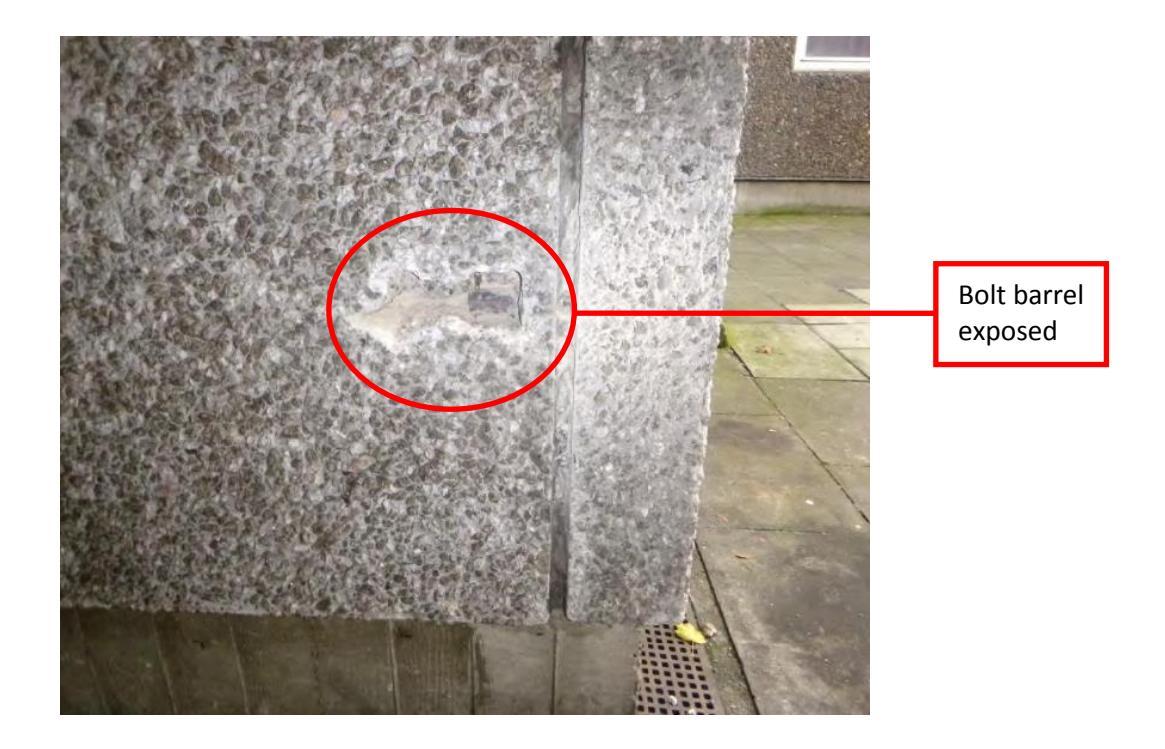
[Figure 5] Stair core bolted connection exposed.

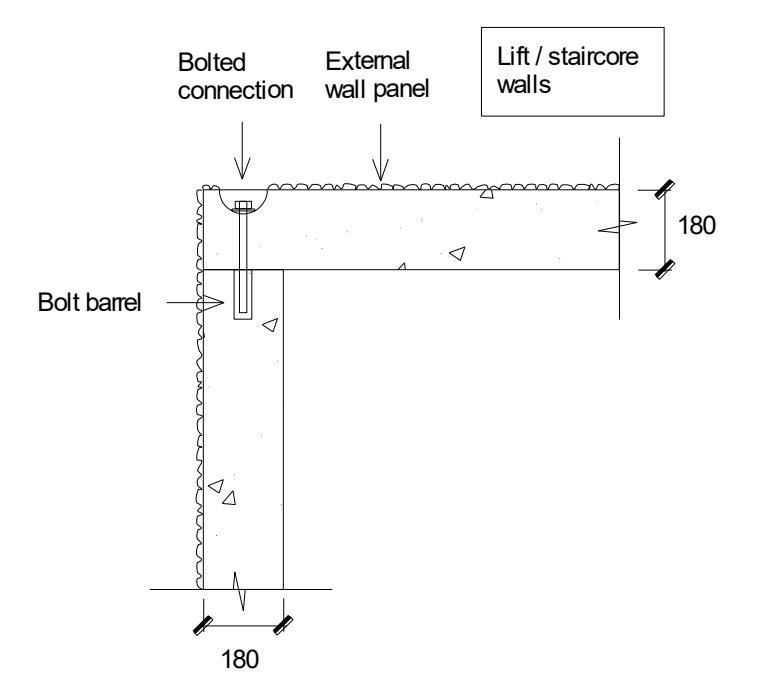
[Figure 6] Stair core bolted connection detail.

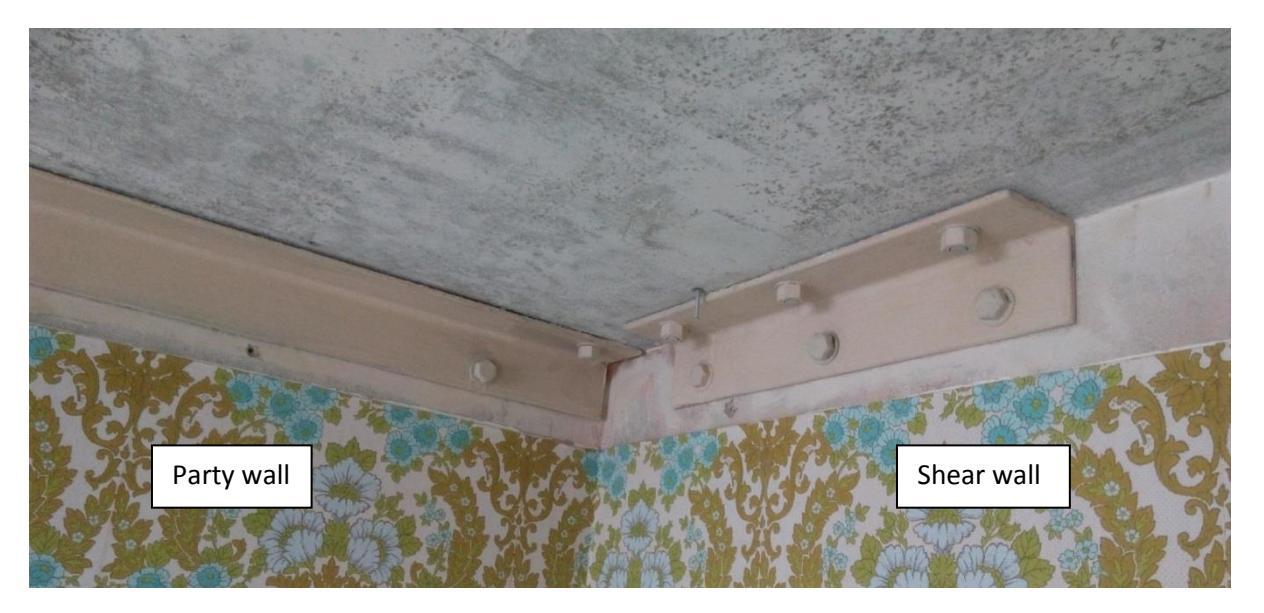
Survey of the flats accessed revealed the existence some degree of strengthening works [Figures 9, 10, 11 & 12]. Steel angles were observed at ceiling level bolted into the ceiling and walls. It is assumed that the bolted steel angles constitute the strengthening works carried out following the Ronan Point gas explosion. The steel angles are installed on the load bearing walls at every level in the flats. Short length steel angles were also observed at the base of the flank wall panels only protruding out of the screed.

[Figure 9] Ceiling level Angles (See Figure 11 for plan view)

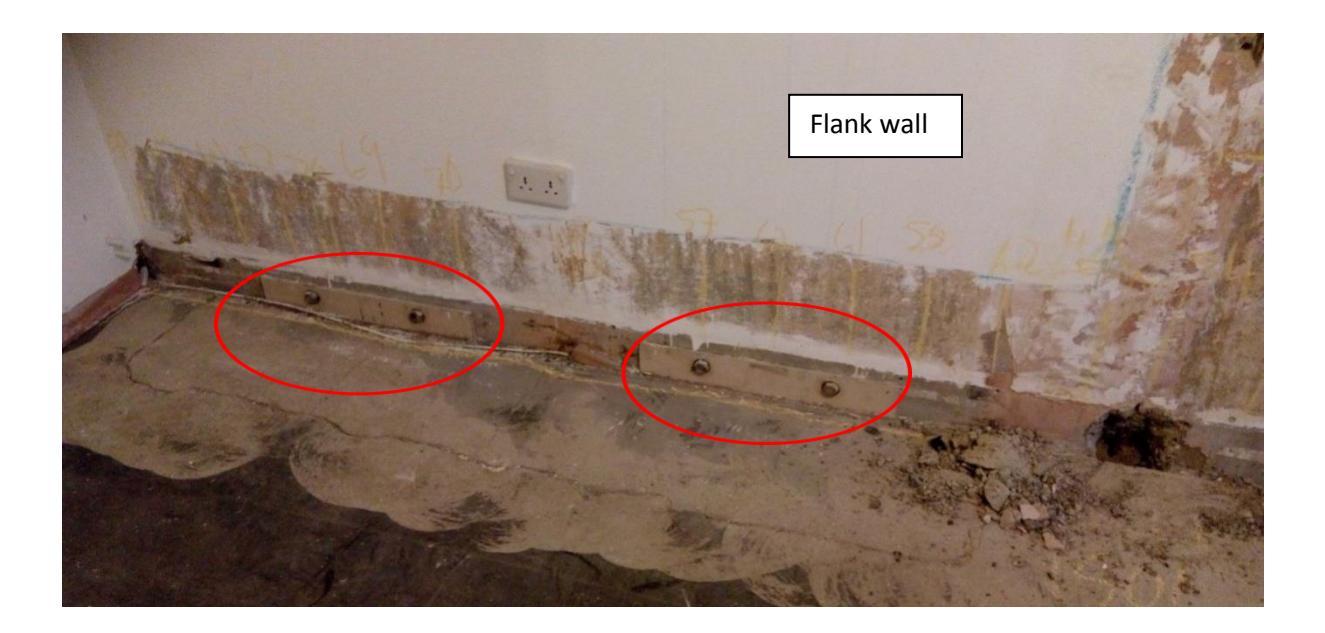
[Figure 10] Floor level Angles – Circled (See Figure 12 for plan view)

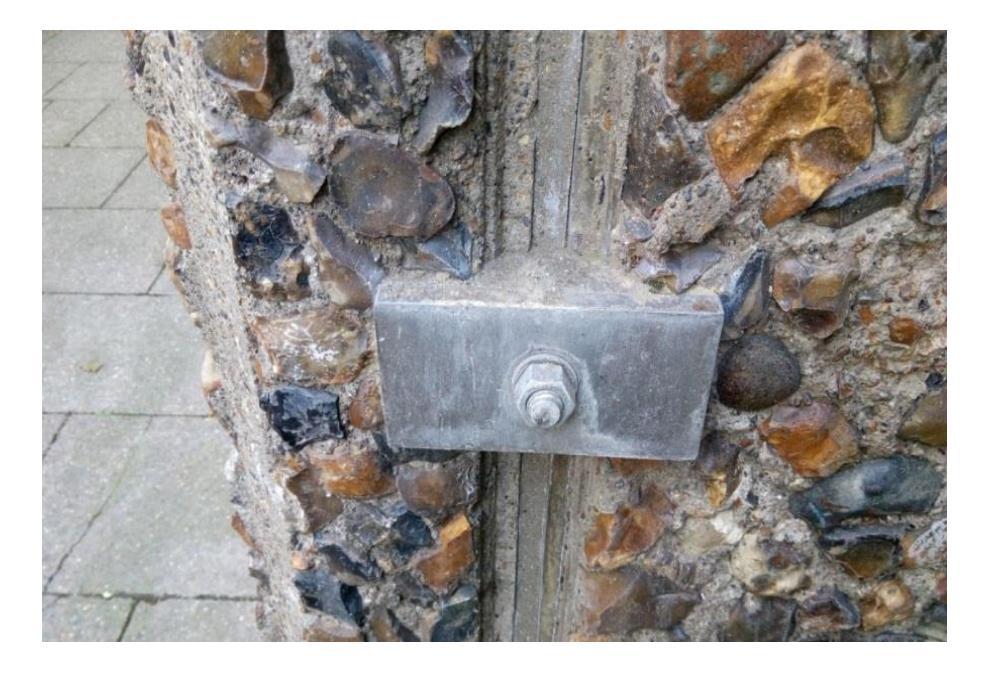
Wall panels P1 and P2 have no vertical interconnecting reinforcement ties but are held in place be tie-back steel plates (Figures 13, 14, 15, 16). Wall panel P2 is a double panel single piece wall unit spanning two rooms.

[Figure 13] External wall restraint

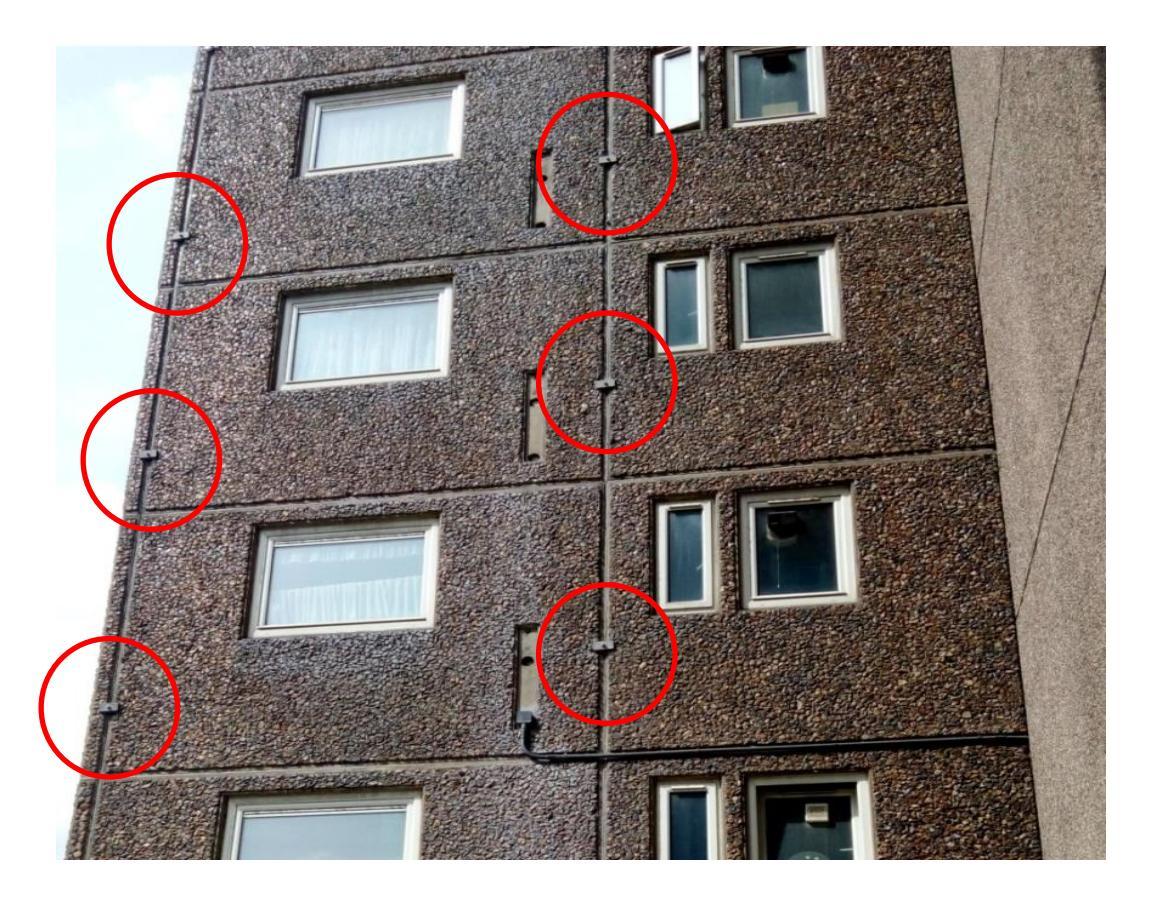
[Figure 14] External wall restraints - Circled

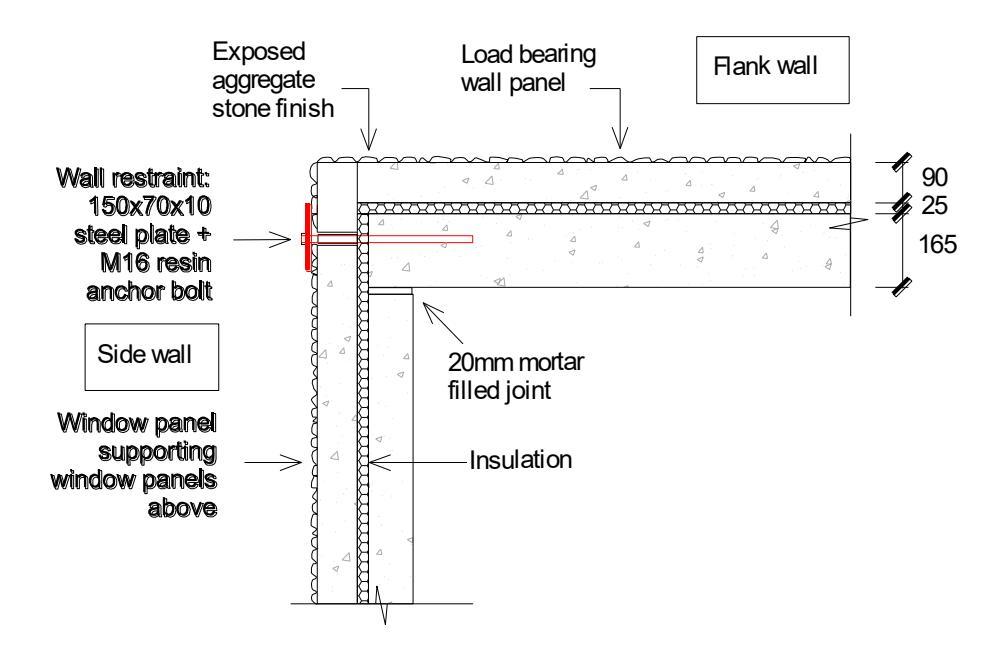
[Figure 15] External wall restraints on the side wall corner of the high-rise.

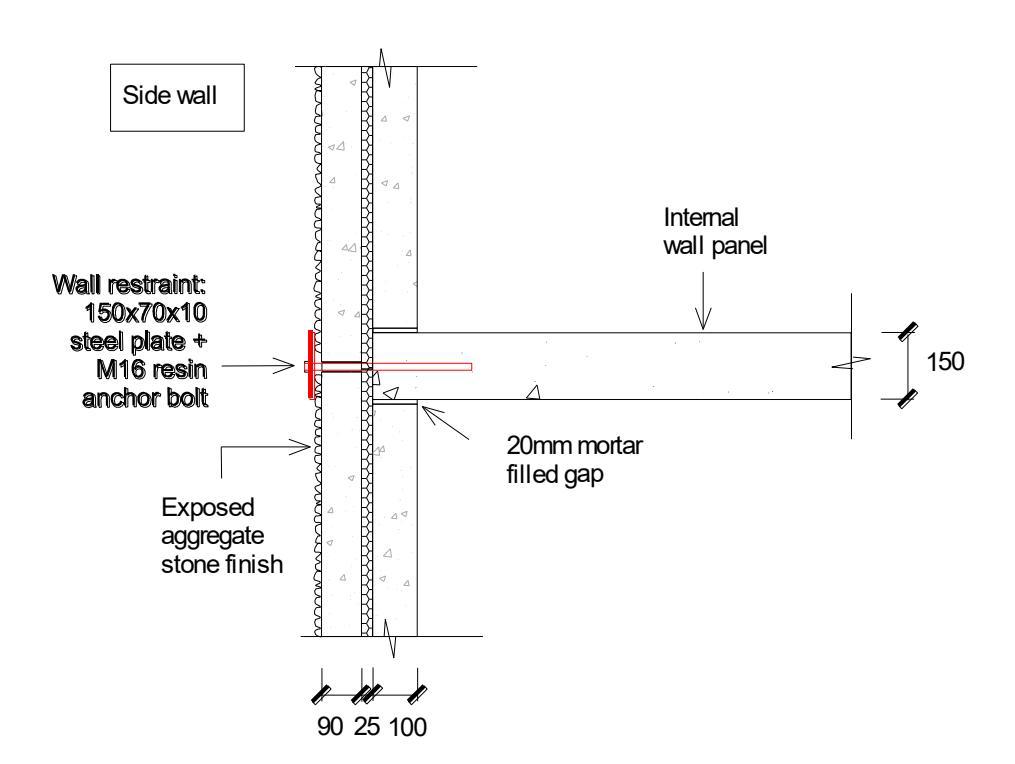
[Figure 16] External wall restraints on the side wall of the high-rise.

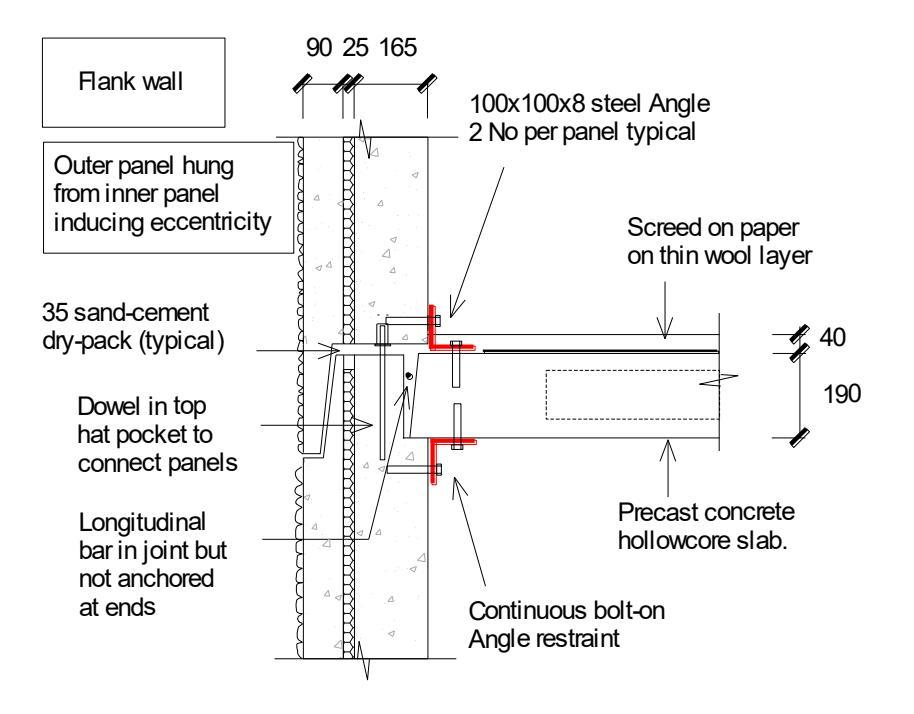
Connection	Observation
1	Flank wall-to-slab connection	Angle brackets and tie-back steel straps are used to tie the floors to the flank walls. See Figure 17. No observed reinforcement tying the flank walls to the concrete floors. The slabs were seated about 70 mm on the inner skin of the sandwich panel and is secured to the wall by a continuous 100x100x8 mm angle with 4M16 bolts per 2.5m wide panels. This bolted connection is seen to further secure the external flank walls to the floor slabs. The feet of the walls were dowelled and anchored to the slabs with 2 No 1.2m long steel angles per panel. The 12mm diameter bar in the floor joint placed longitudinally was not anchored at the ends. Although the flank wall appears better tied than the others, it is still inadequate for tie-back under collapse conditions.
2	wall connection	8 mm projection loops and a 12 mm lacer bar. The lacer bar was not continuous into the upper or lower level panels. See Figure 21.

[Figure 17] Flank wall connection to the floor slab.

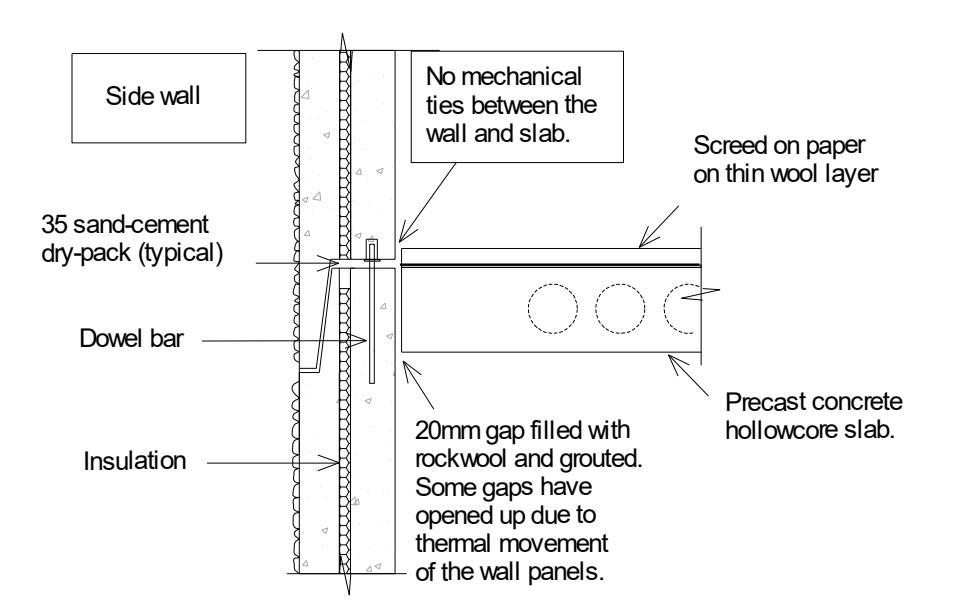
3	Cross wall to slab connection	150mm thick panel wall [type 2] with no clear ties to concrete slab or walls above and below. The top of the cross walls are bolted to the soffit of the concrete slabs with continuous steel angles similar to that of the flank wall but on both sides of the wall. The bases of the cross walls are not connected vertically or horizontally. See Figure 19.
4	Side wall to flank wall connection	The panels are recessed at the ends and only grouted. No mechanical connections were found. See Figure 15.
5	Side wall to cross wall connection	The side wall panel joints are grouted only. No mechanical ties observed. Stainless steel externally mounted tie-back plates were used as lateral restraint to stabilise the side wall panels. Two tie-back anchor plates were observed per panel. See Figure 16.
6	Side wall to slab connection	The only tie-back strap connection between side wall and slab was located at ground floor. The absence of these in the upper floors has resulted in the side wall panels bowing and gaps opening up especially between the double-panel side walls and the floor slab. See Figure 18.

[Figure 18] Side wall connection to the floor slab.

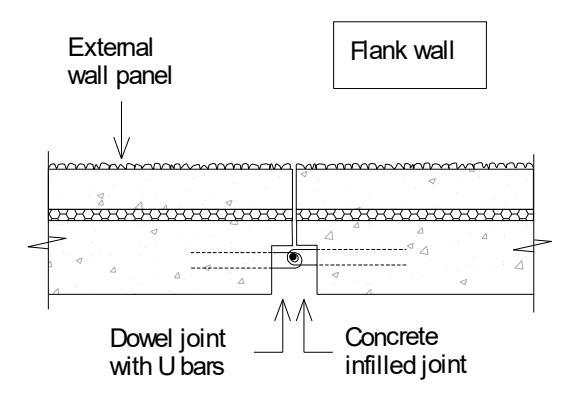
[Figure 21]: Flank wall panel connection

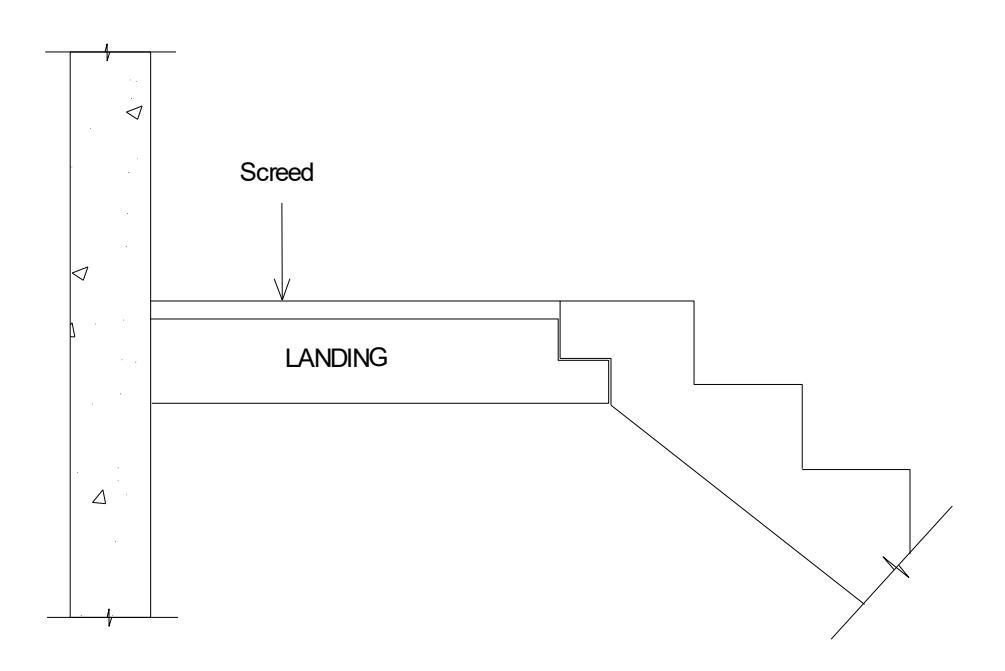
12	Stair to landing Connection	A halving joint connection was identified; however, no mechanical ties were observed between the stair flight and the landing slab. See Figures 28 & 39.
13	Landing to wall connection	The landing slabs were seated on concrete corbels at every floor level. No mechanical ties were observed. See Figure 29.
14	Link bridge to residential block slab connection	The link bridge slab is supported on beams both at the stair and residential block ends. The stair end connection is not tied, possibly considered as an expansion joint in design. Thermal movement of up to 10mm was observed in the floor joints between the access tower and residential block at the top level. See Figure 23.
15	Link bridge wall to slab connection	The link bridge wall panels are supported at each level on the slab edge. The wall panels are tied back to the bridge slab with two tie-back anchor plates per panel. See Figure 7.

[Figure 28]: Stair and landing details

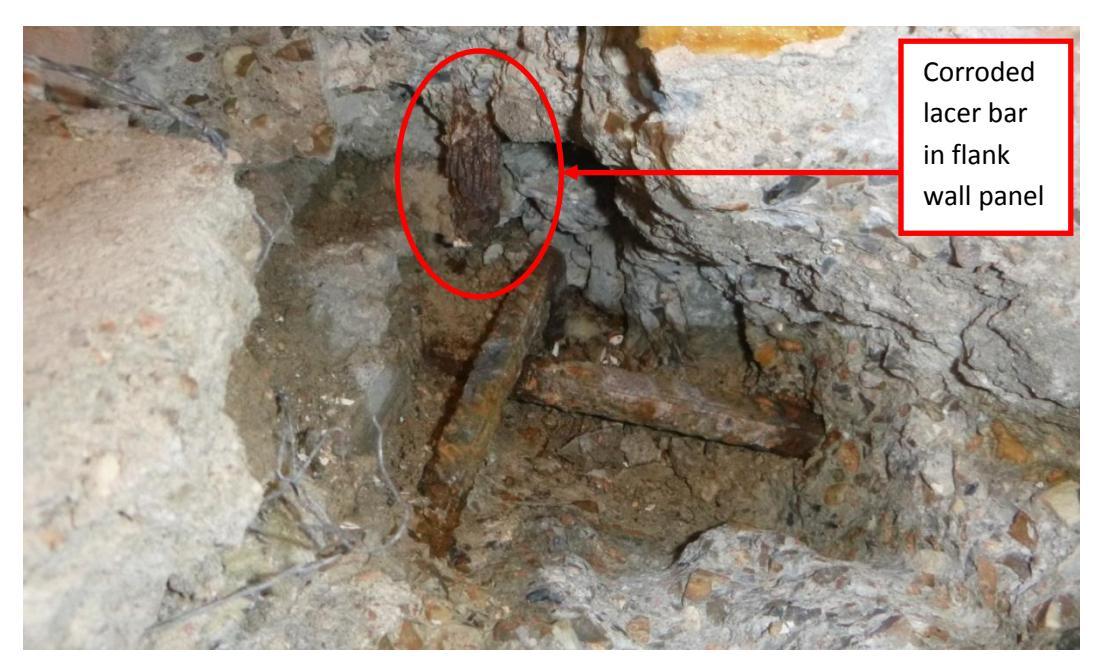
Some degree of reinforcement corrosion was observed in the flank wall of the ground floor flat.

[Figure 33] Reinforcement corrosion found in flank wall panel

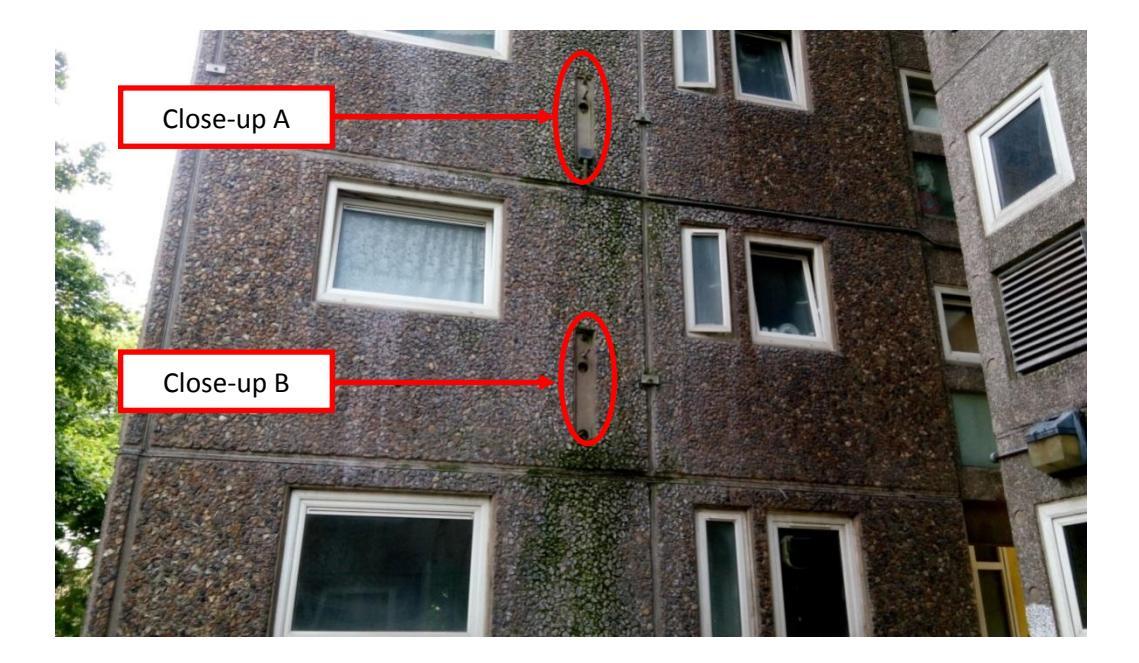
Long term continual water flow onto the rear walls of the residential blocks will eventually encourage reinforcement corrosion when damp reaches into the fabric of the concrete panels.

[Figure 34] Waste water overflow pipes (circled) sticking out of the rear wall of the block. White residue water stains were observed on the dry face of the rear walls, and green coloration of vegetation on the damp face.

- (a) Inspect the kitchen and bathroom waste water drain pipes (including the sink) in all the flats for leaks and faulty connections. Any water leaks found are to be stopped and the joints repaired and/or sealed.
- (b) Inspect the kitchen and toilet cistern overflow to all flats for faulty mechanism. The overflow pipes which drain out into the air are to be redirected into the internal drainage or connected externally to a new downpipe which will take the overflow water into the external underground drain.
- (c) The mastic seals to the concrete panel joints are to be surveyed and faulty seals are to be remedied to stop rain water ingress into the property. Driving rain into the link bridge also requires attention.

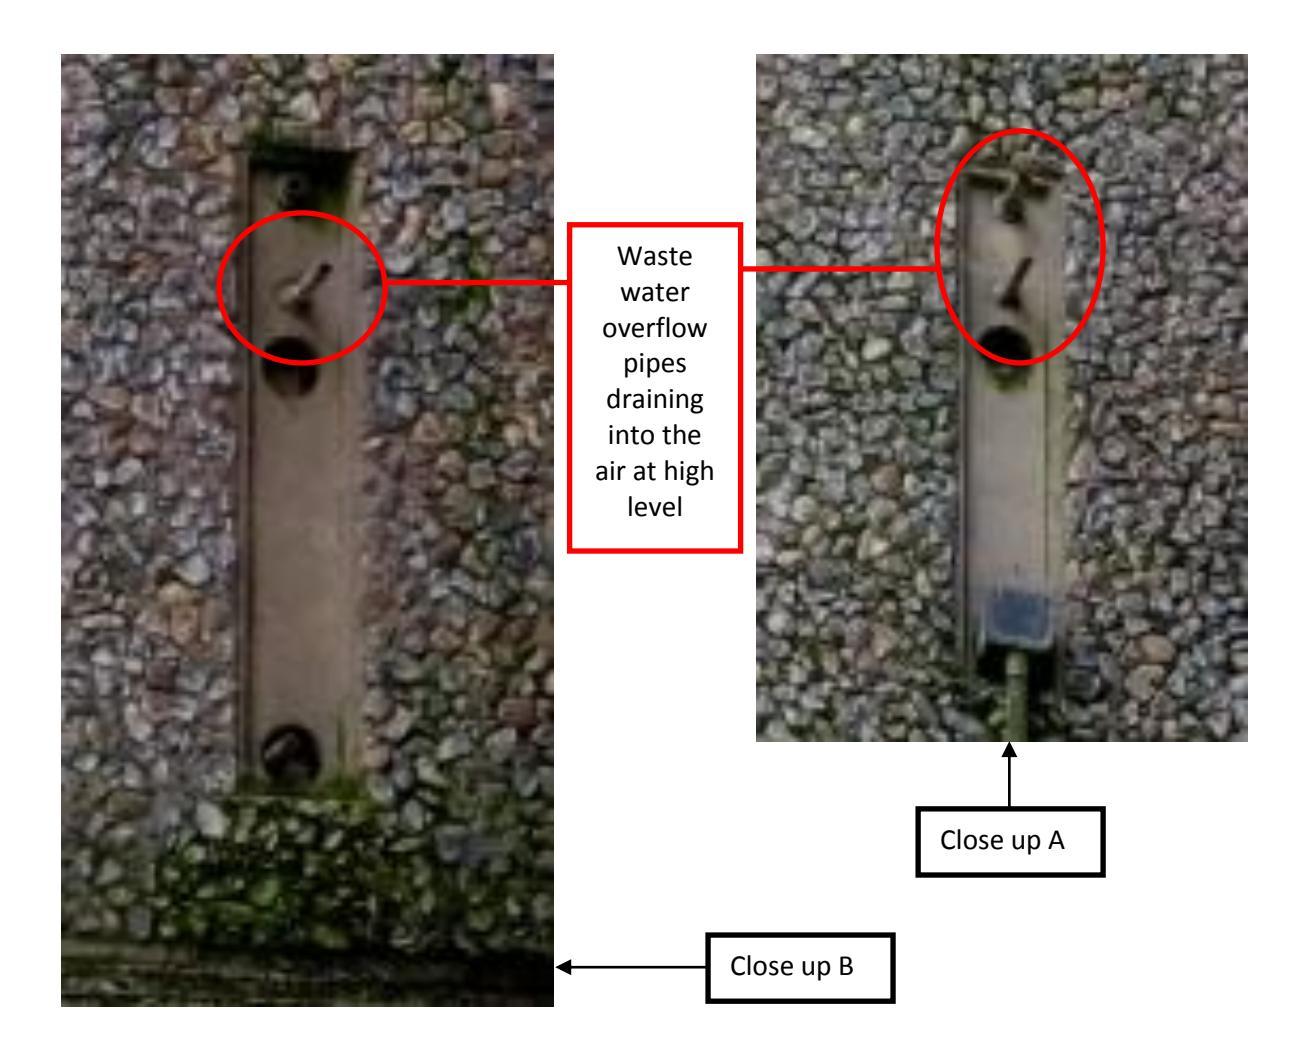
[Figure 35] Close-up on overflow pipes to Figure 19

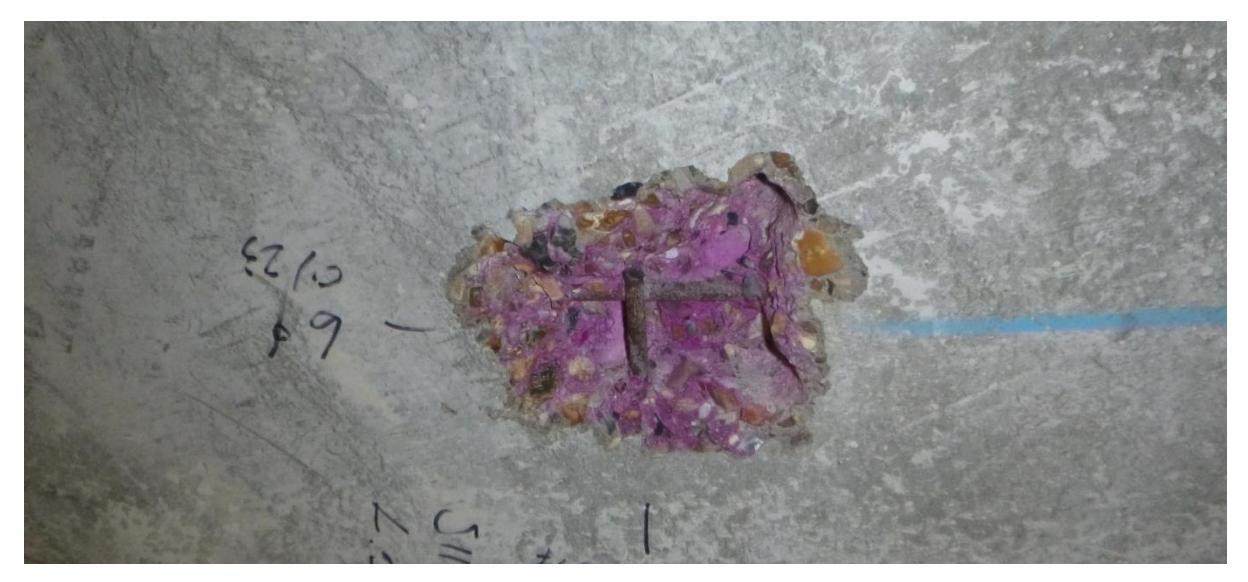
Carbonation and chloride levels in the concrete were tested in a few locations. The levels measured were generally low. Testing for chlorides gave negligible results.

[Figure 36] Carbonation identification coloration in soffit of concrete floor

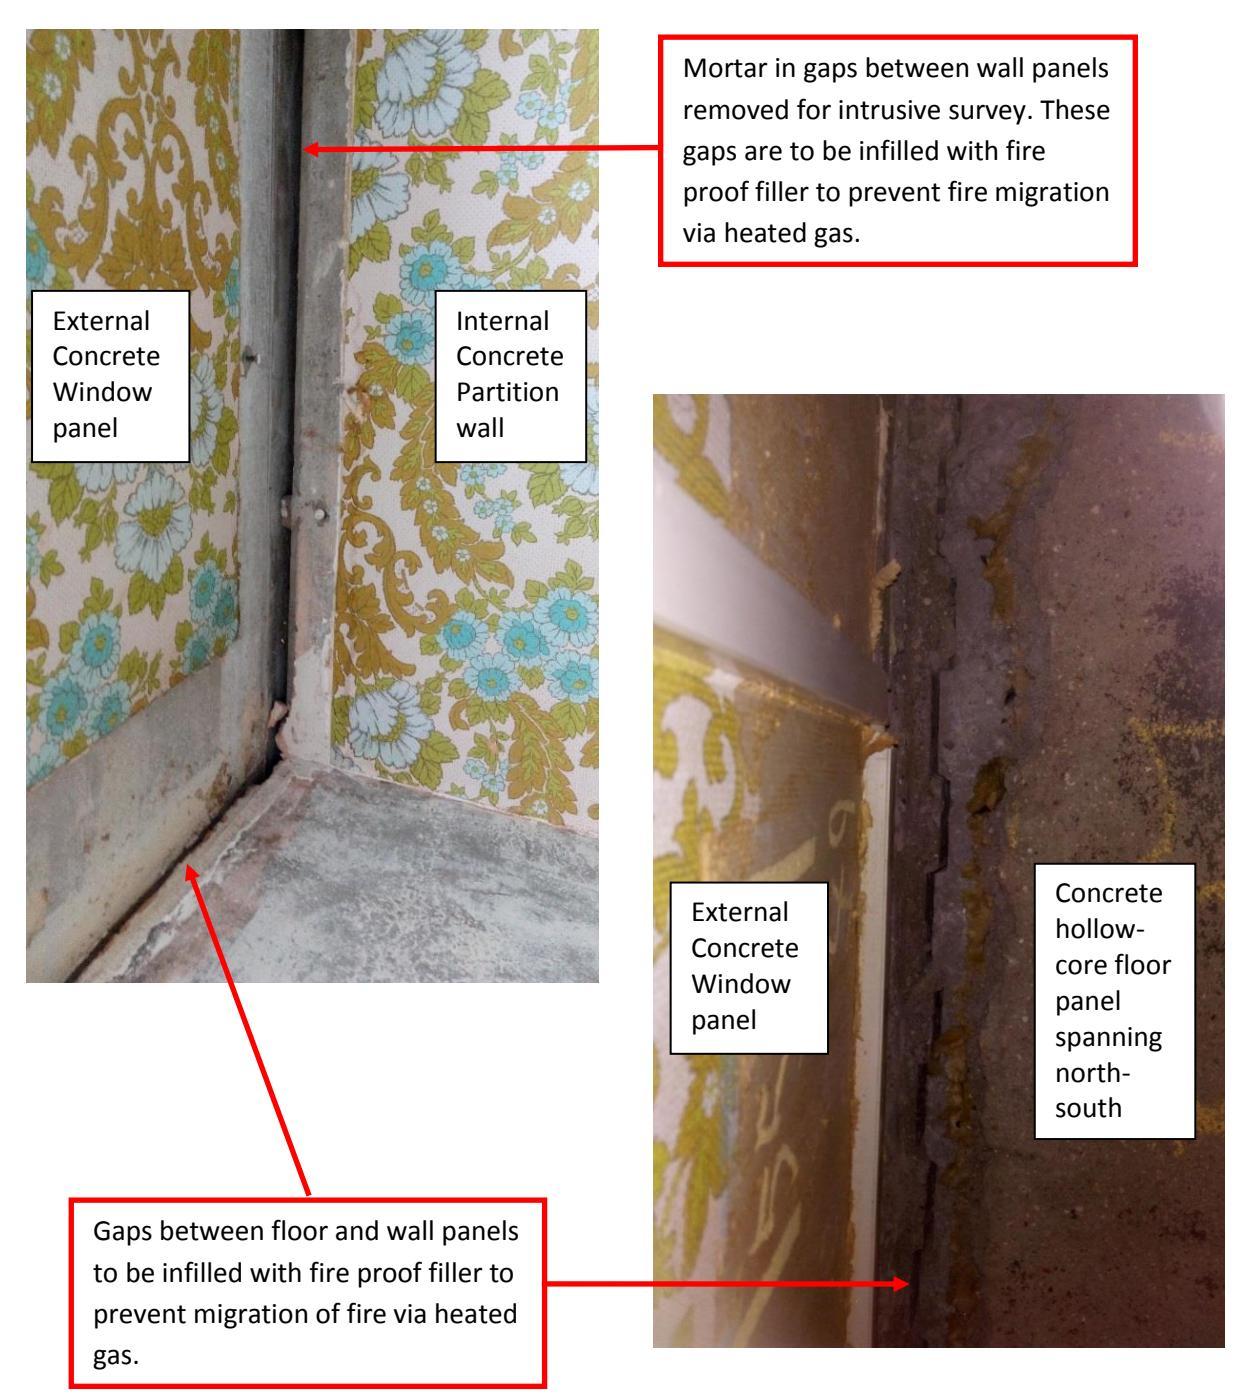
[Figure 37] Gaps in panel joints

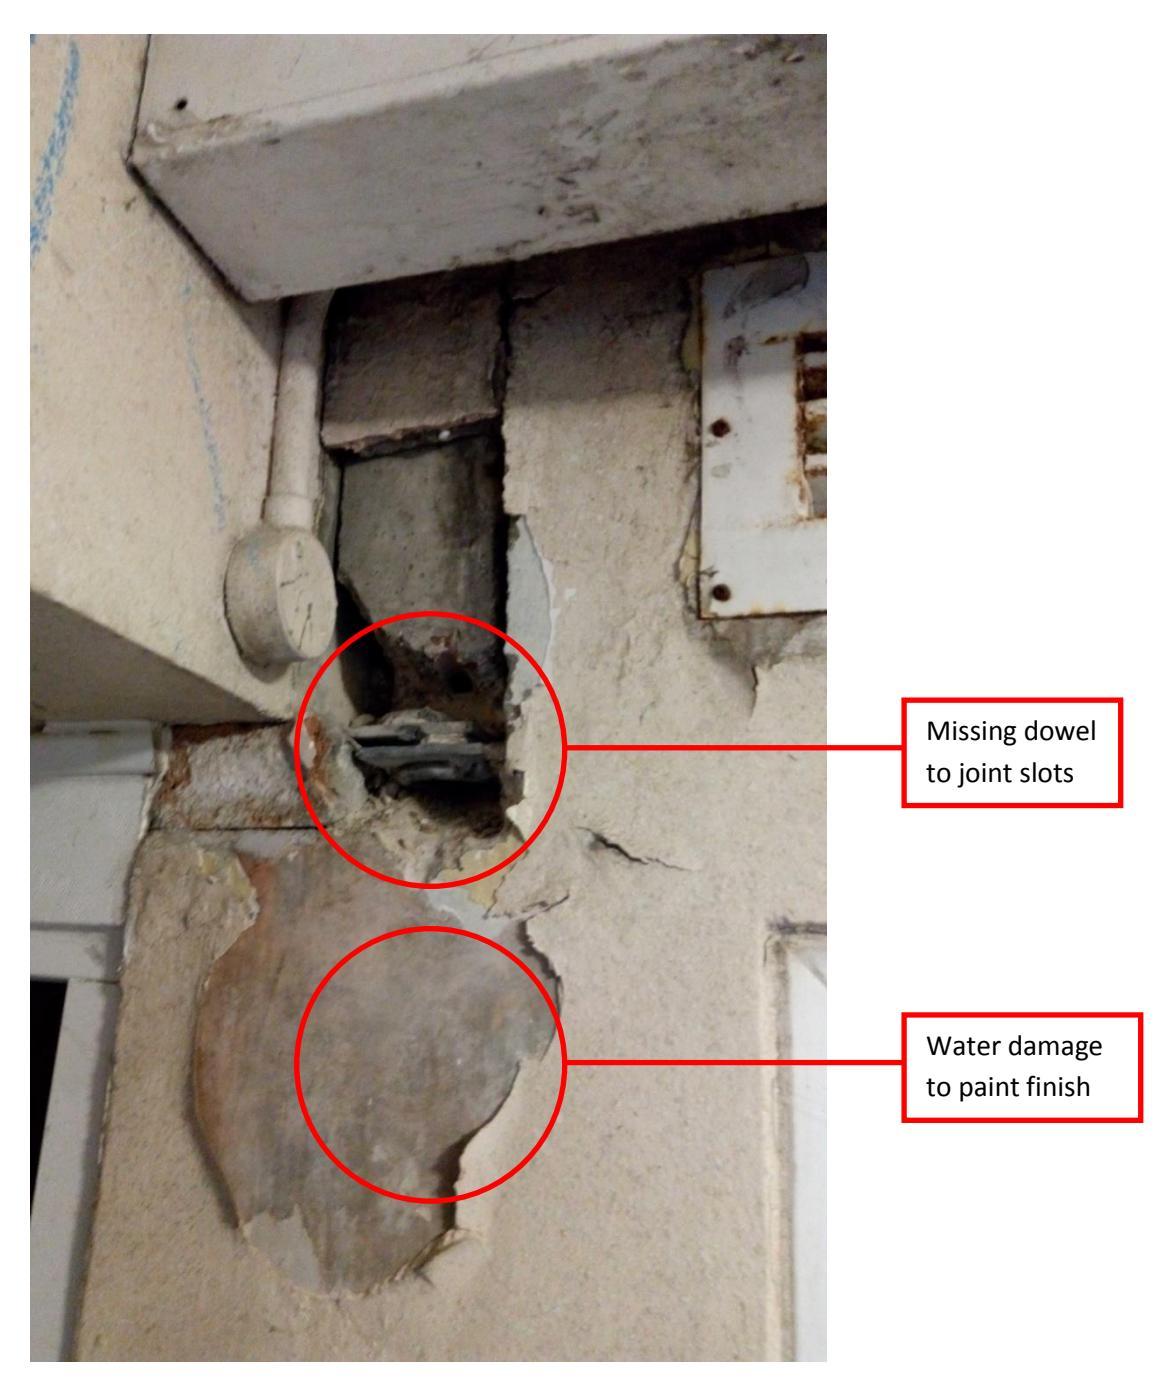
[Figure 38] Dowel missing in link bridge wall joint

The joint face in the top corner of the link bridge was broken out to expose the jointing and to investigate why there were cracks around the jointing. Some water damage to the paint finish was observed.

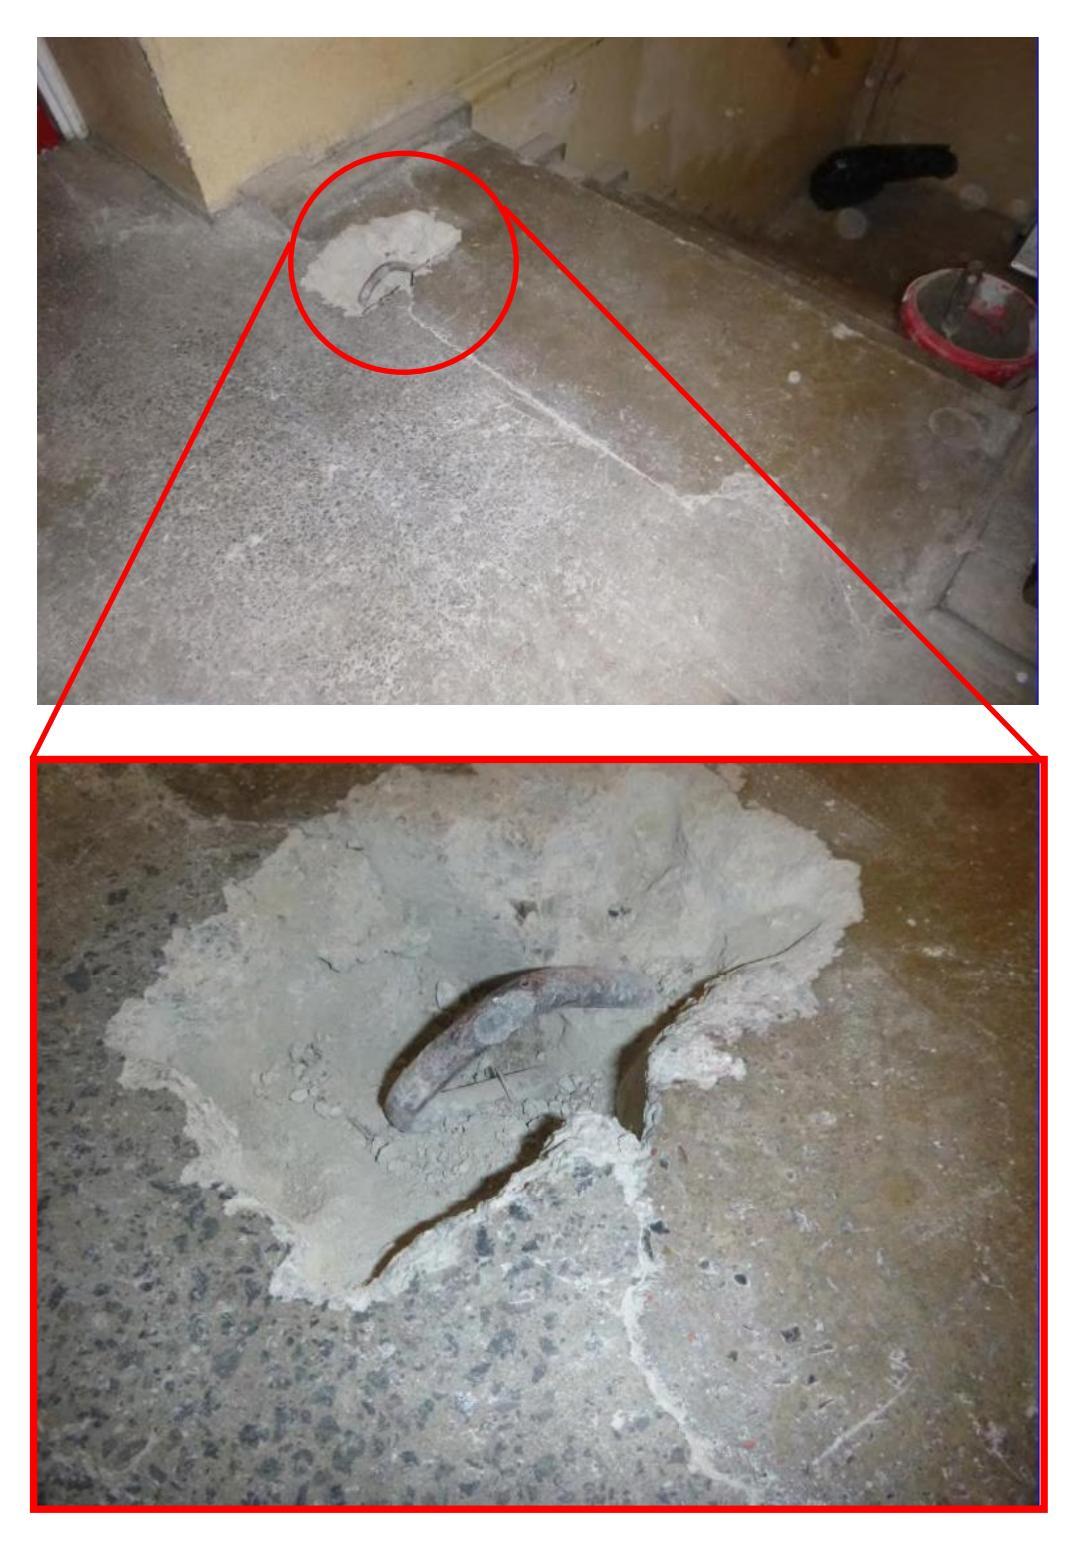
The stair landing at level 12 was investigated to see whether the precast units were tied together by reinforcement. Figure 15 below is a photo of what was uncovered. No tie back reinforcement was found in the connection.

[Figure 39] Tie-back reinforcement missing in landing-to-stairs connection.

No tie-back reinforcement was observed in the breakout. It is therefore assumed that the stairs and landing construction at all levels were built or connected together without internal ties.
