London Borough of Hammersmith &
Fulham

Hartopp Point & Lannoy Point
Structural Assessment

Issue 1 | 12 February 2019

Job number 259559-00

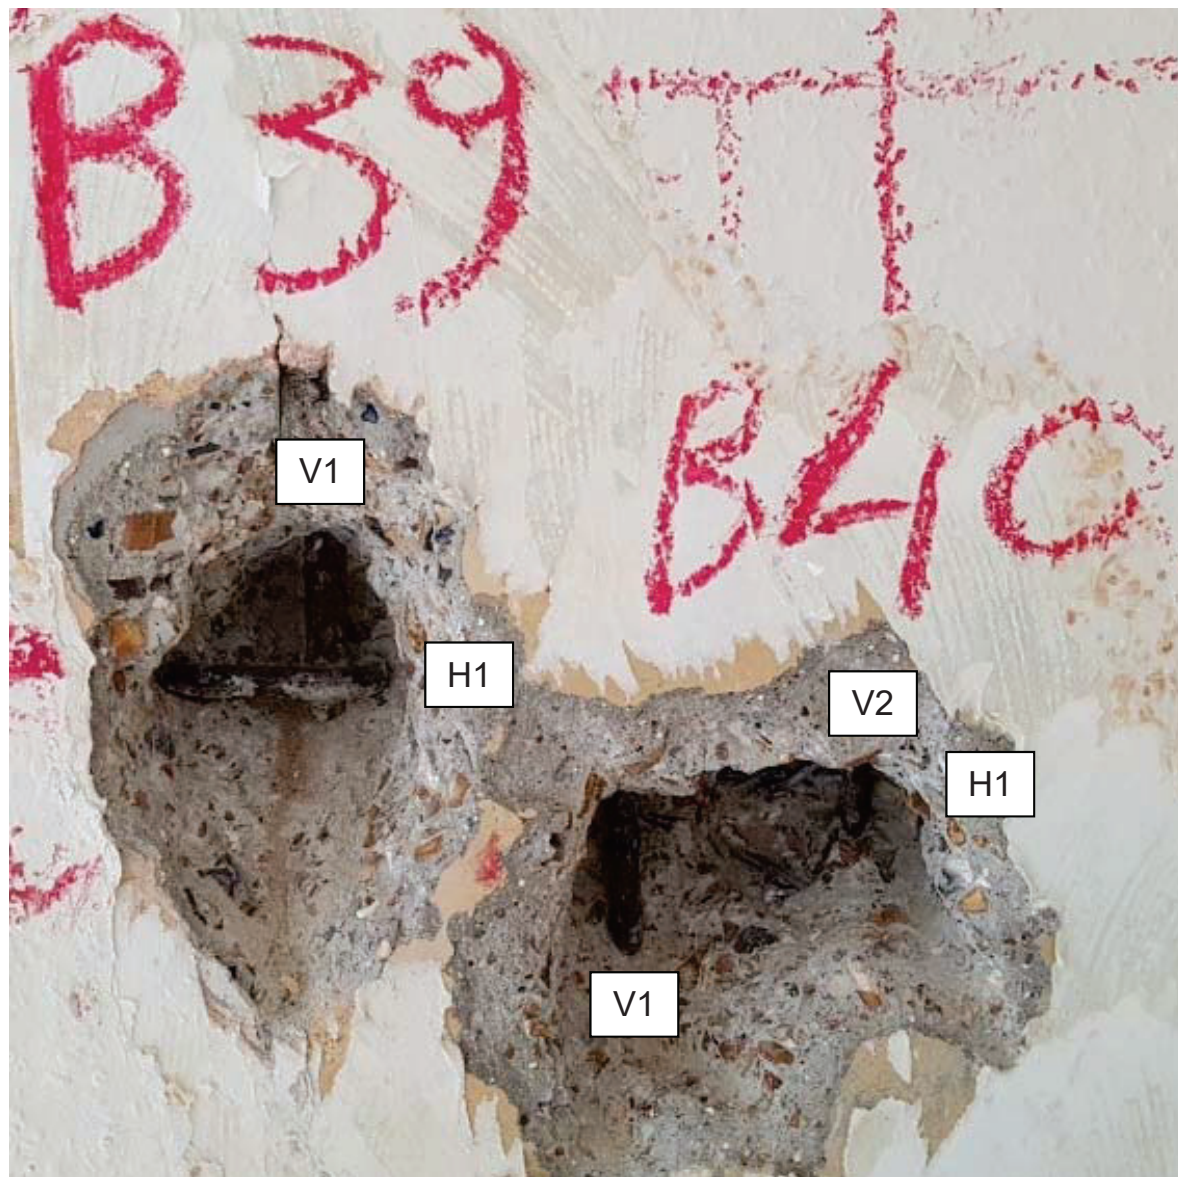
SITE	DETAILS	DATE	CONTRACT NO.	INITIALS
Lannoy Building – Flat 12	Ferrosan Survey – Living Room Wall A	August 2018	SUR183482	MAH/PW/ JI

B39	V1	H1
<i>Bar Ø (mm)</i>	12	10
<i>Bar Type</i>	Round, Smooth	Round, Smooth
<i>Min. Cover (mm)</i>	54	71
<i>Condition</i>	Light Surface Corrosion	Light Surface Corrosion

B40	V1	V2	H2
<i>Bar Ø (mm)</i>	12	6	6
<i>Bar Type</i>	Round, Smooth	Round, Smooth	Round, Smooth
<i>Min. Cover (mm)</i>	66	66	73
<i>Condition</i>	Good	Good	Good
