HARTOPP & LANNOY HIGHRISE BUILDINGS

Structural Assessment of Hartopp and Lannoy Highrise Buildings Aintree Estate

STAGE (II) REPORT

Project No: 2017/01426/design 08 October 2018

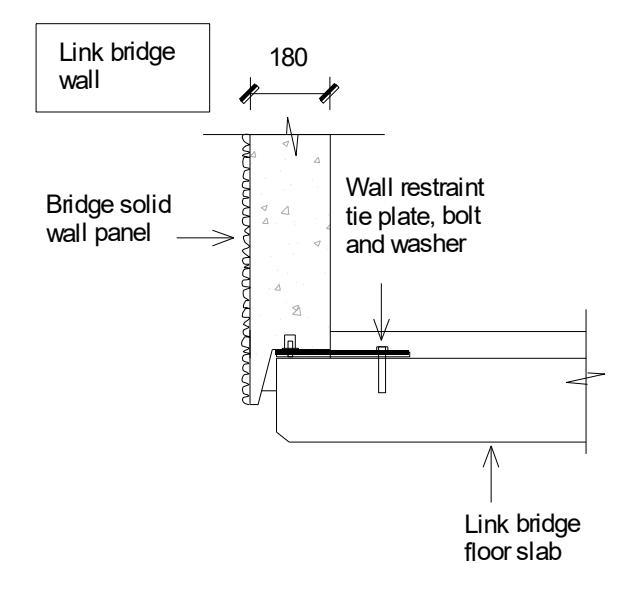
[Figure 7] Section through Link Bridge at first floor.

12	Stair to landing Connection	A halving joint connection was identified; however, no mechanical ties were observed between the stair flight and the landing slab. See Figures 28 & 39.
13	Landing to wall connection	The landing slabs were seated on concrete corbels at every floor level. No mechanical ties were observed. See Figure 29.
14	Link bridge to residential block slab connection	The link bridge slab is supported on beams both at the stair and residential block ends. The stair end connection is not tied, possibly considered as an expansion joint in design. Thermal movement of up to 10mm was observed in the floor joints between the access tower and residential block at the top level. See Figure 23.
15	Link bridge wall to slab connection	The link bridge wall panels are supported at each level on the slab edge. The wall panels are tied back to the bridge slab with two tie-back anchor plates per panel. See Figure 7.

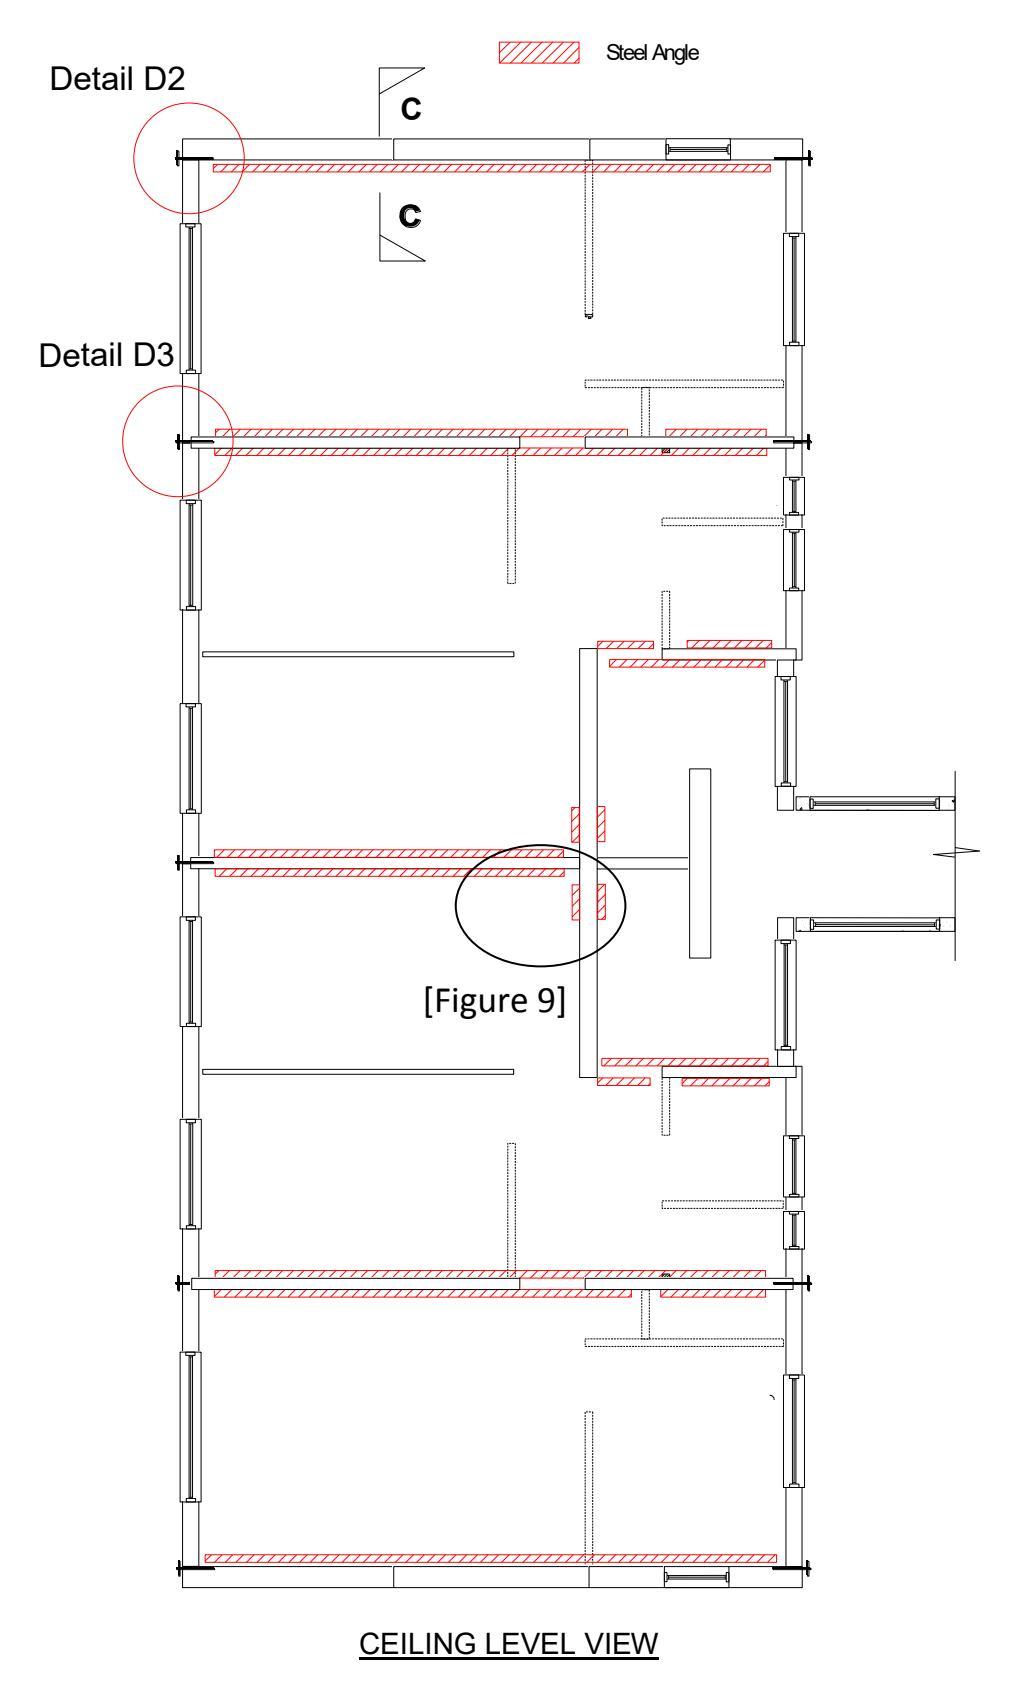
[Figure 11] Existing strengthening Angles

Survey of the flats accessed revealed the existence some degree of strengthening works [Figures 9, 10, 11 & 12]. Steel angles were observed at ceiling level bolted into the ceiling and walls. It is assumed that the bolted steel angles constitute the strengthening works carried out following the Ronan Point gas explosion. The steel angles are installed on the load bearing walls at every level in the flats. Short length steel angles were also observed at the base of the flank wall panels only protruding out of the screed.

Angle sections - 100x100 RSA typical

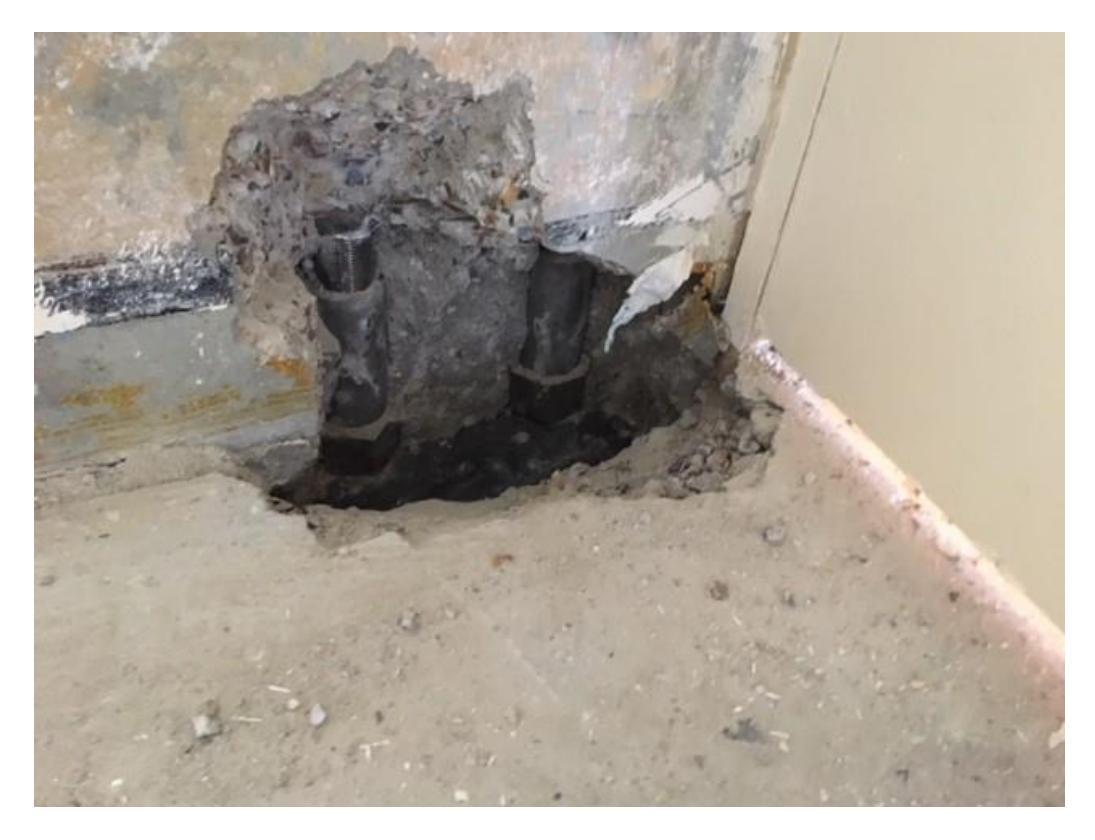
7	Side wall to wall vertical connection	The side wall panels are dowelled vertically. Dowels from the panels below project up into a steel top-hat cast into the bottom of the panels above. See Figure 18.
8	Side wall to 65mm thick partition wall connection	The joint is grouted only. The partition panel is supported by the floor slab and dry packed top and bottom. No dowels were observed between the wall and slab.
9	Shear wall to Party wall connection	This was a grouted connection; no mechanical ties were found.
10	Shear wall to slab connection	Bolted steel angles at ceiling level. Head of wall restrained to side of slab with Angles.
11	The shear wall to wall vertical connection	2 No 32mm diameter anchor bars were observed at the ends of the shear walls with threaded couplers connecting them together vertically.

[Figure 31] Tension bars in ends of 235mm thick shear wall

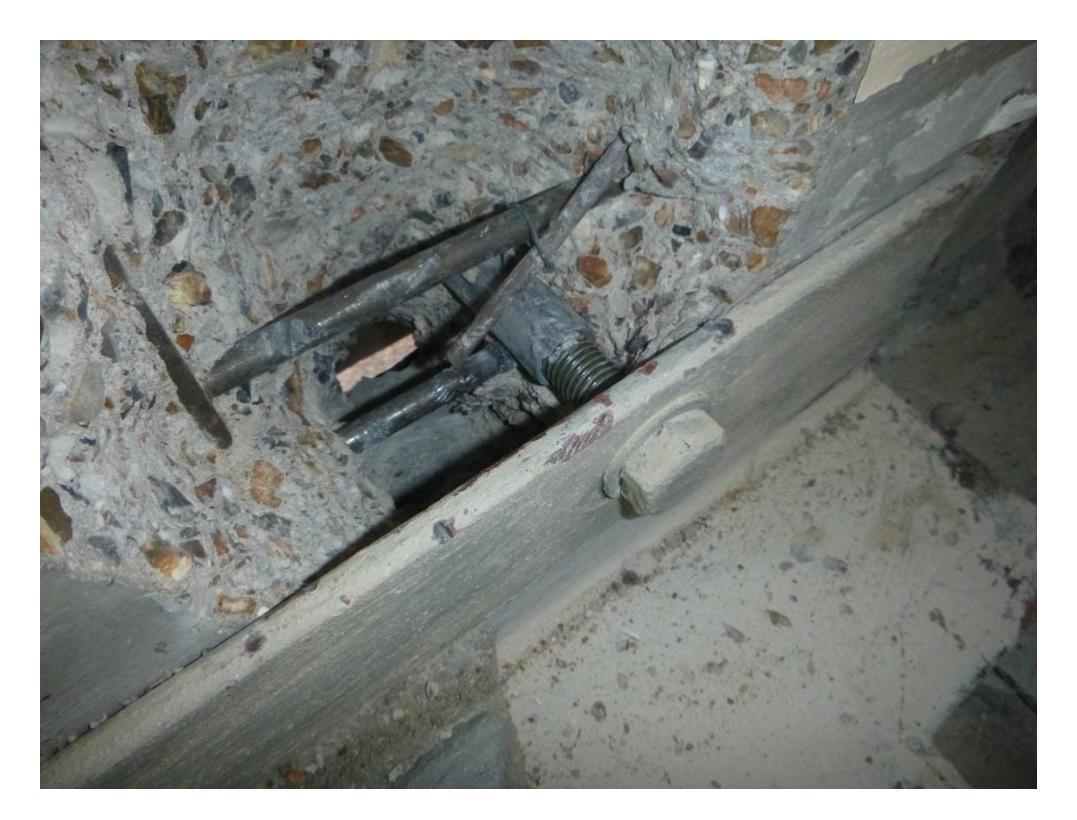
[Figure 32] Bolted Angle fixing into flank wall

Connection	Observation
1	Flank wall-to-slab connection	Angle brackets and tie-back steel straps are used to tie the floors to the flank walls. See Figure 17. No observed reinforcement tying the flank walls to the concrete floors. The slabs were seated about 70 mm on the inner skin of the sandwich panel and is secured to the wall by a continuous 100x100x8 mm angle with 4M16 bolts per 2.5m wide panels. This bolted connection is seen to further secure the external flank walls to the floor slabs. The feet of the walls were dowelled and anchored to the slabs with 2 No 1.2m long steel angles per panel. The 12mm diameter bar in the floor joint placed longitudinally was not anchored at the ends. Although the flank wall appears better tied than the others, it is still inadequate for tie-back under collapse conditions.
2	wall connection	8 mm projection loops and a 12 mm lacer bar. The lacer bar was not continuous into the upper or lower level panels. See Figure 21.
