1 INTRODUCTION

2.1 The Ingersoll and Arminger Conservation Area was designated on the 17 January 1990.

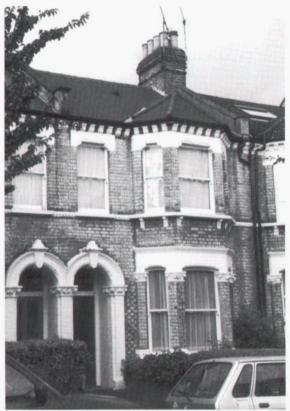
5.3 These streets form a cohesive group of two storey Late Victorian properties. Built of a grey gault brick there is stone ornament around the doors, timber sash windows to the two storey bay

windows and corbels to the eaves. Many retain their original doors with stained glass panels, and the tiles within the recessed porches can still be seen in places.

5.4 The properties have pitched slate roofs with hipped roofs to the bays originally with ornamental ridge tiles and finials which remain in places. Consecutive properties are handed, producing a pleasing rhythm of paired front doors and adjacent bays with paired chimneys.

Terraced property in Arminger Road

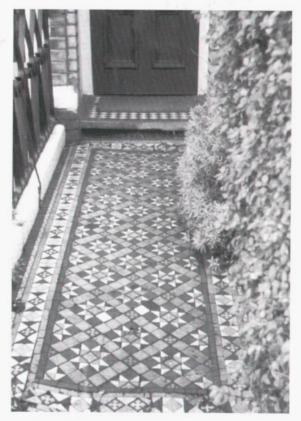
5.11 The original front boundary in most cases consisted of capped brick piers and railings on dwarf brick walls with copings. The brick piers have survived in many cases and should be retained. Where railings are missing hedges provide a pleasing alternative. There are some good tesselated tiled paths to front doors (e.g. York House, Merton Villa) which should be retained.

Detail of tiled front path

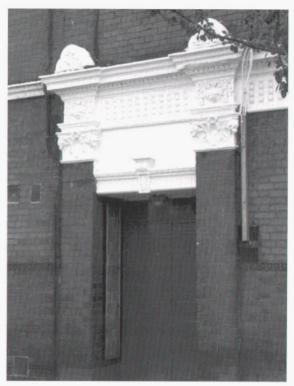
Detail of door surround to side entrance of the locally listed Carlton Snooker Club

Carlton Snooker Club (BOM) which was formerly the Carlton Ballroom. It dates from about 1907 and W F Hurdall was the owner. Originally called Carlton Hall it was owned by the London County Council in 1942 and used as a British Restaurant. It reopened as a private Dance Hall in 1952.

5.18 The first floor has French windows opening onto a flat roof with a cornice above which acts effectively as a break before the bay window in Georgian style. The facade is topped by a rendered parapet with a pineapple located at each end and an urn centrally. The white rendered
