1 INTRODUCTION

2.1 Melrose conservation area was designated in April 1989

3.1 The Melrose Conservation Area is bounded by the northern side of Poplar Grove, the western side of Melrose Terrace and the southern side of Melrose Gardens. Its eastern boundary takes in Nos. 48-104 & Nos. 55a-65 Shepherd's Bush Road, Nos. 228-240 & 177-183 Blythe Road, 108 Lakeside Road and Nos. 1-4 & 5-15 Netherwood Road. It includes Poplar Grove, Melrose Terrace and Gardens and Cromwell Grove.

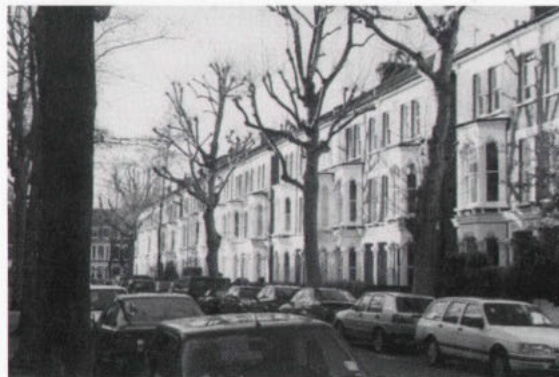
View west along Cromwell Grove

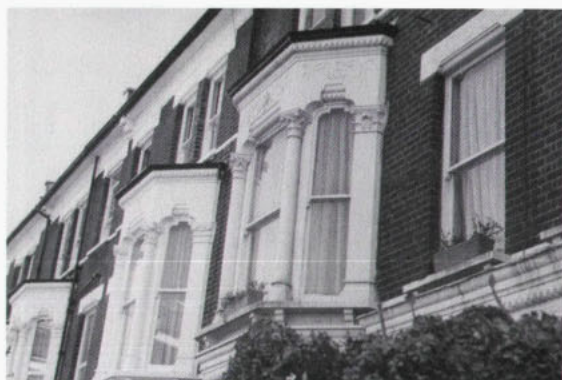
5.6 The red brick properties on the north side of Poplar Grove have blind window details on the front elevation at the party walls of every other pair corresponding with the paired bays. This simple detailing gives this terrace a more refined rhythm.

Detail of terraced properties in Poplar Grove

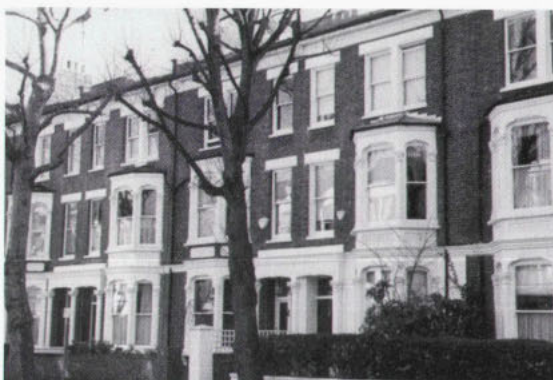
Terraced properties in Melrose Gardens

5.10 Views to the rear of terraces within and outside the conservation area are important. The rhythm created by the rear additions and the chimneys to these and the main building is of particular note. The gaps between the rear of terraces where terraces meet at right angles are characteristic of the area and an important element in defining its character. The majority of the terraces are split into blocks of six properties and the views to the rear in the gap between these blocks are an important feature.

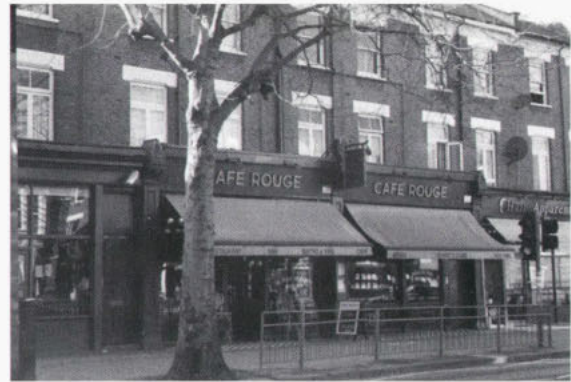
Good shopfront on Shepherds Bush Road

5.16 The shopfronts are of varying quality and there have been numerous modern replacements which fail to respect the form and appearance of the traditional shopfronts. A particular problem is the increasingly large fascia signs of modern materials. In some instances the shopfronts continue around the return of terraced properties, which is important in addressing the balance between the commercial and residential nature of the respective streets. No. 62 Shepherds Bush Road retains its original shopfront and No 98, the Cafe Rouge, retains some of the original tiles of the previous butcher/grocer both inside and outside the premises.
