Hammersmith Bridge

Safe Operation of
Hammersmith Bridge

Issue 1

December 2020

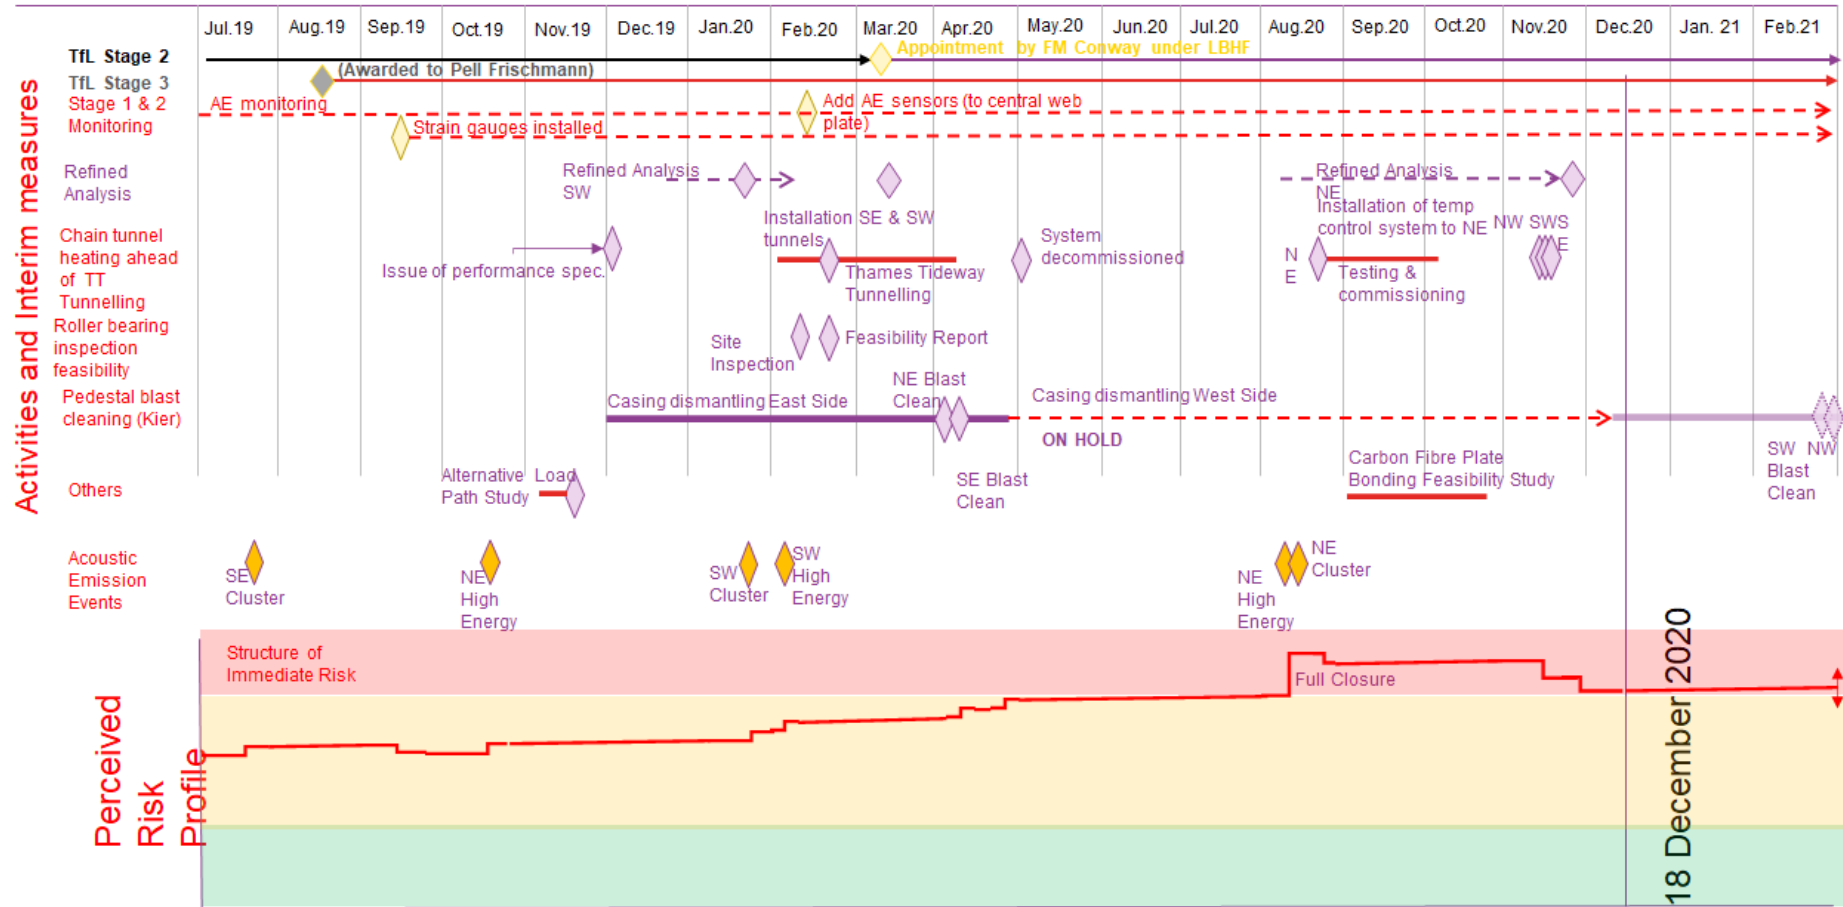
Timeline and Risk Profile

Annexed to this report is a timeline which details major events since 2017, which began with a clear expectation that the condition of the bridge was something that must be subjected to thorough analysis. The timeline is accompanied by an estimate of perceived safety risk associated with major events. This climbs with the passage of time leaving it as a “*structure of immediate risk*”, a self-explanatory term.

The impact of all these things is summarised in this timeline:
